██████████
██████████ Pawling Ave
Troy, 12180
HIN™: 121806288
Email: ██████████
Inspection Date: 05-28-2014

Hollis Home Inspection
J Hollis Allison
199 Green st Hudson, New York 12534
Phone: (518) 421-6069
E-Mail: hollishomeinspection@gmail.com

Welcome and thank you for choosing Hollis Home Inspection.
 This report is designed to be as thorough as possible, but also clear and concise.
 If you have any questions please call us at (518) 421-6069

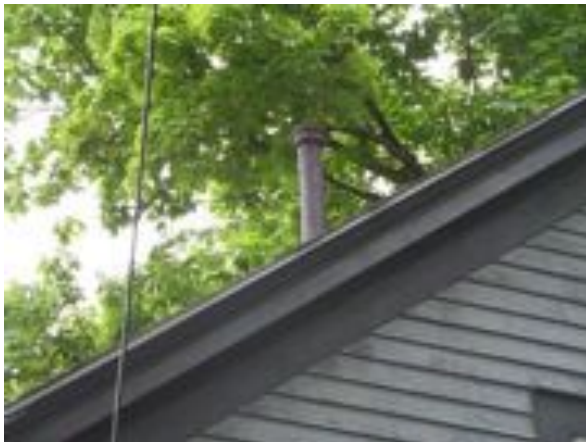
Roof

Trees are overhanging roof and are within 10 feet of roof vertically. Trees may threaten roof structure in the event of a collapse. Trees may deposit leaves and debris on roof which may lead to clogged gutters or roof deterioration. Recommend having a qualified arborist provide remedy.

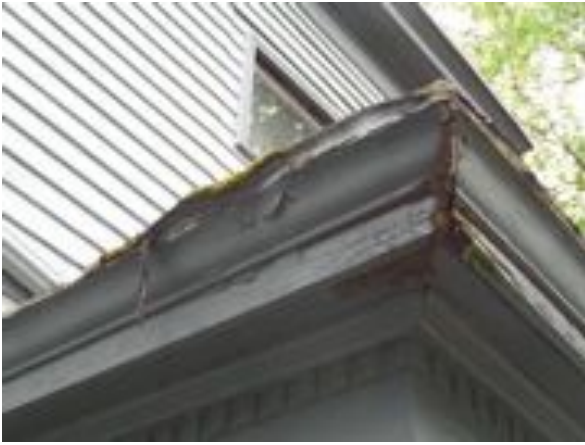
Moss noted on asphalt shingles. This can lead to deterioration of roof decking due to water being leached under the shingles by the moss. Recommend a qualified contractor repair as necessary.

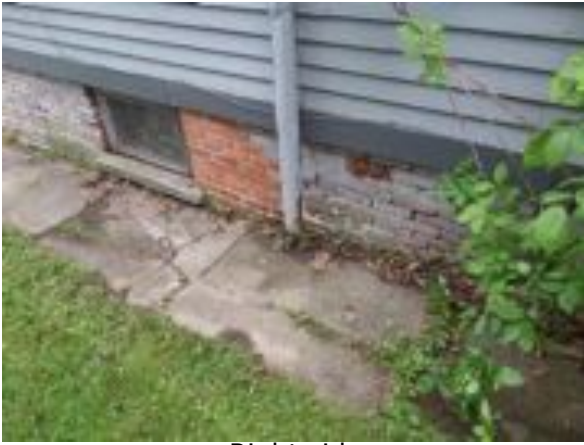
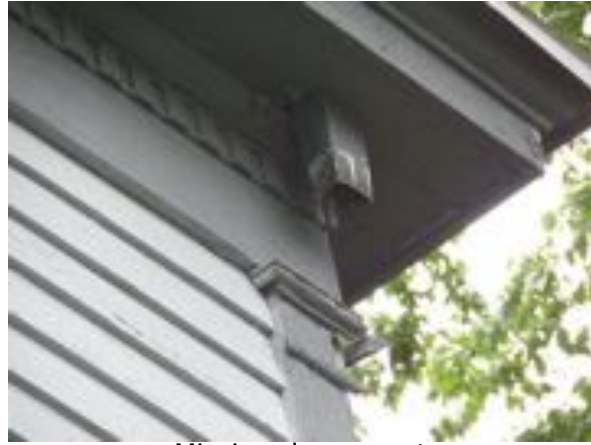
Right side

Downspouts appear to missing or inadequate at directing water away from house and foundation. This condition may allow moisture to enter the house and may cause deterioration of exterior surfaces. Recommend hiring a qualified contractor to repair as necessary.

Missing downspout

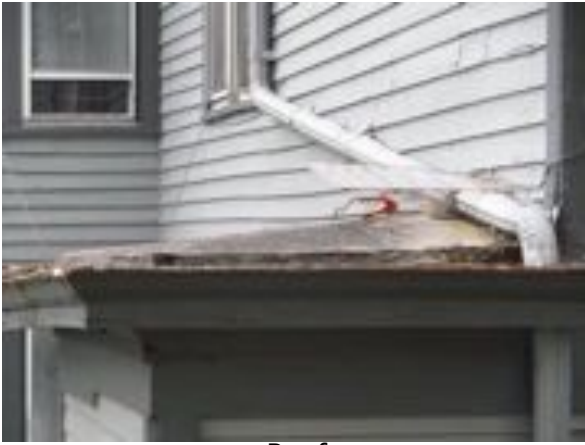
Roof over 142 half bath may be leaking. Evidence of moisture penetration found in half bath where ceiling meets wall. If not addressed, moisture may continue to cause damage. Recommend hiring a qualified roofing contractor to repair as necessary. (see Half Bath 142).

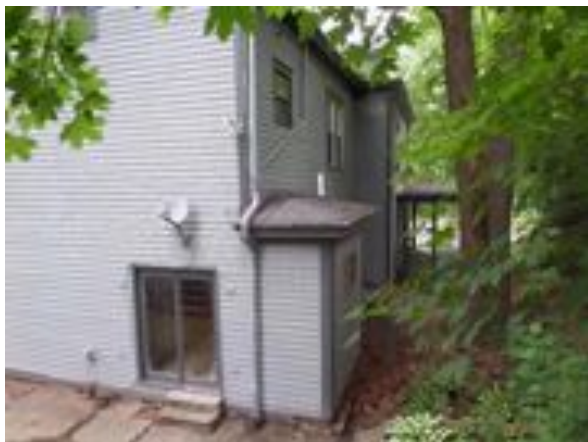
Rear Left

Roof covering installation on rear left of 1st floor roof appears to not meet standard building practices. Asphalt shingles were used on a low slope roof and fail to change direction when crossing the hip. Although no leak was detected at time of inspection, it is recommend to monitor this roof and surrounding areas for signs of moisture intrusion. If leak is found, have a qualified roofing contractor repair as necessary.

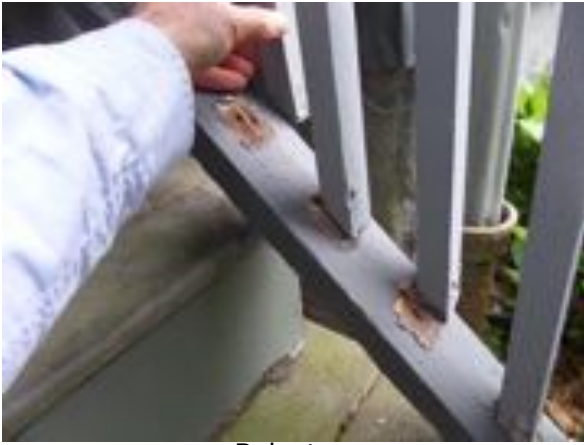
05/29/2014 144 side porch steps noted with detached balusters. Balusters are designed to safely guard occupants from injury. Detached balusters may become detached, may pinch or otherwise injure occupants, or may fail to perform as designed. Recommend hiring a qualified contractor to repair as necessary.

144 side porch steps noted with detached balusters. Balusters are designed to safely guard occupants from injury. Detached balusters may become detached, may pinch or otherwise injure occupants, or may fail to perform as designed. Recommend hiring a qualified contractor to repair as necessary.

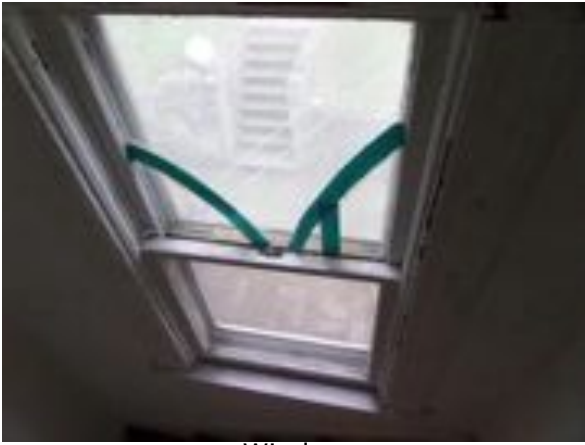
Window

05/29/2014 Multiple windows noted with cracked glazing. Cracked glazing may cause risk of laceration as well as air, moisture, and vermin infiltration. Recommend hiring a qualified contractor to repair as necessary.

Multiple windows noted with cracked glazing. Cracked glazing may cause risk of laceration as well as air, moisture, and vermin infiltration. Recommend hiring a qualified contractor to repair as necessary.

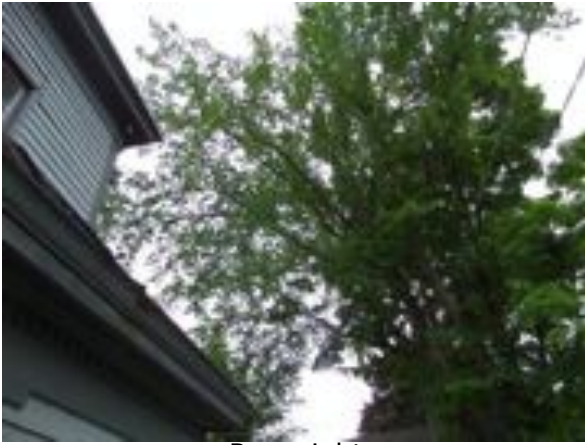
Rear right

05/30/2014 Overhead electric service wires threatened by tree overhead. Tree limbs may interfere with or fall on wires which may put occupants at risk of shock/fire and/or cause damage to wires. Recommend contacting utility company to provide remedy.

Overhead electric service wires threatened by tree overhead. Tree limbs may interfere with or fall on wires which may put occupants at risk of shock/fire and/or cause damage to wires. Recommend contacting utility company to provide remedy.

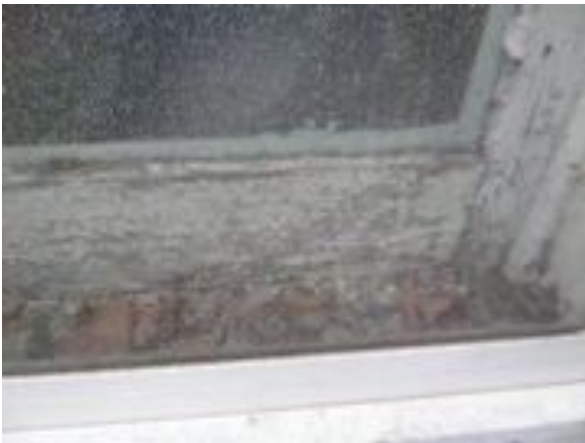
Window

Wooden windows noted in need of repair. Missing glazing compound and deterioration noted in multiple windows. Glazing compound helps to hold glass and shed water from window. Recommend hiring a qualified contractor to repair as necessary.

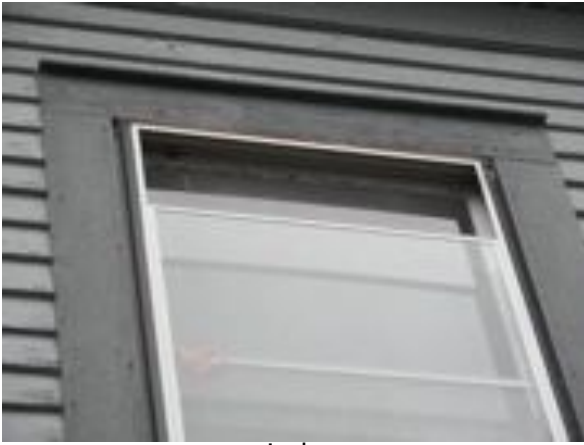
More than one window was missing storm window sash. Storm windows help keep the elements away from the window. Missing storm sash may allow moisture and debris to remain on window sill. Storms may also help maintain an efficient thermal envelope.

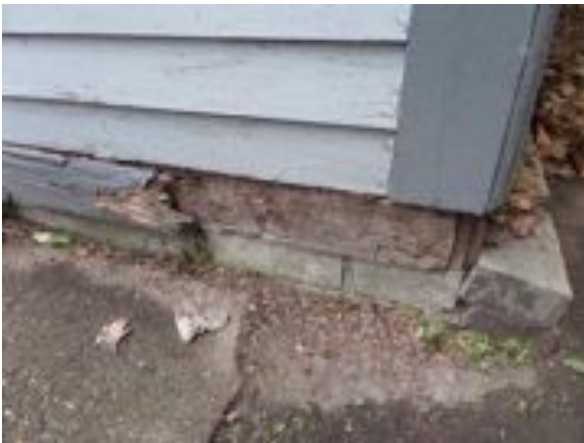
Sill area

Deterioration where house meets foundation noted at time of inspection. Siding/sheathing/and wood sill beam noted moist and soft in multiple areas. This condition may lead to exposure of the wooden structural members to the elements and further deterioration. Recommend hiring a qualified contractor to repair as necessary.

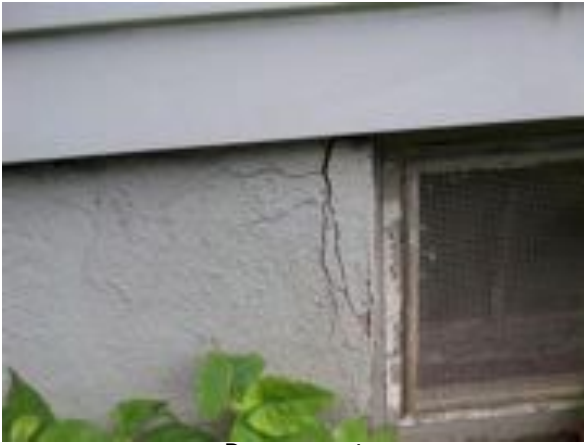
Parge coat

Parge coating covering brick foundation wall noted as cracked and/or falling off of brick. Parge coating is designed to protect and seal brick foundation. Recommend repair as necessary by qualified masonry contractor.

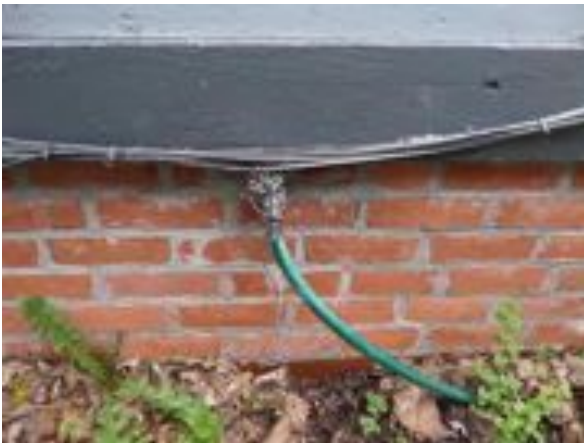
Right side

Leaky sillcock noted on right side of building at time of inspection. A leaky sillcock may deposit water close to the foundation which may enter the basement. Recommend hiring a qualified plumbing contractor to repair as necessary.

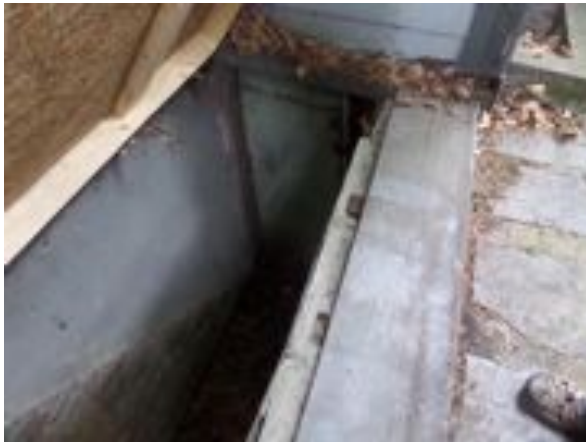
05/29/2014 Hatch covering cavity for basement stairs (which may have previously existed) noted as not secure. Hatch could be opened creating a potential for fall or other injury. This condition may allow entry of unwanted pests or burglars. Additionally, this uninsulated opening may allow air infiltration and reduce thermal efficiency. Recommend hiring a qualified contractor to repair as necessary.

Hatch covering cavity for basement stairs (which may have previously existed) noted as not secure. Hatch could be opened creating a potential for fall or other injury. This condition may allow entry of unwanted pests or burglars. Additionally, this uninsulated opening may allow air infiltration and reduce thermal efficiency. Recommend hiring a qualified contractor to repair as necessary.

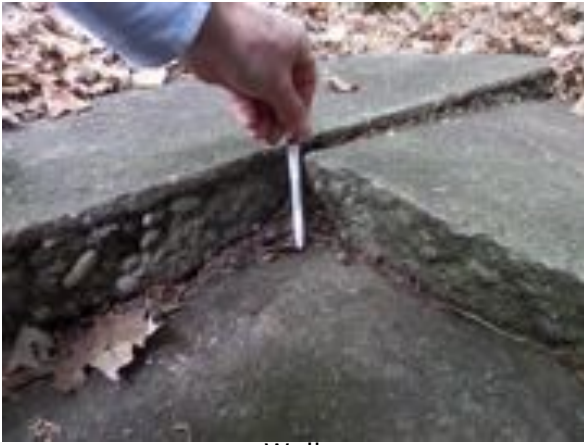
Walk

05/29/2014 Walkway on left side of house appeared heaved. This may be due to tree roots pushing from underneath. Uneven and non-level walk may pose a trip/fall hazard to occupants. Recommend hiring a qualified contractor to repair as necessary.

Walkway on left side of house appeared heaved. This may be due to tree roots pushing from underneath. Uneven and non-level walk may pose a trip/fall hazard to occupants. Recommend hiring a qualified contractor to repair as necessary.

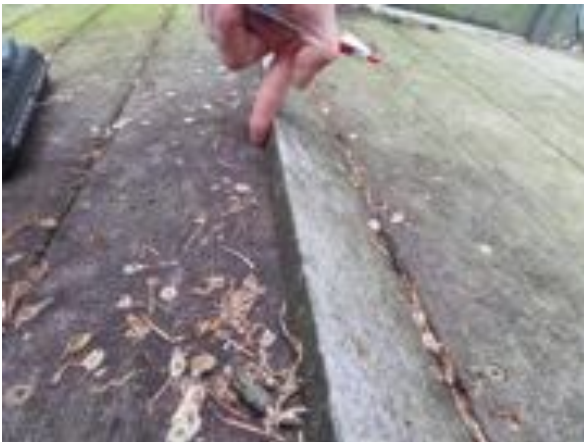
05/29/2014 Ramp on right side of building observed in unsafe condition. Decking member seen protruding above surface creating a potential trip hazard. Board ends observed spongy and unsupported on fence side which may pinch or fail to support occupants. Structure underneath ramp was not visible so structural integrity could not be verified. Recommend hiring a qualified contractor to repair as necessary.

Ramp on right side of building observed in unsafe condition. Decking member seen protruding above surface creating a potential trip hazard. Board ends observed spongy and unsupported on fence side which may pinch or fail to support occupants. Structure underneath ramp was not visible so structural integrity could not be verified. Recommend hiring a qualified contractor to repair as necessary.

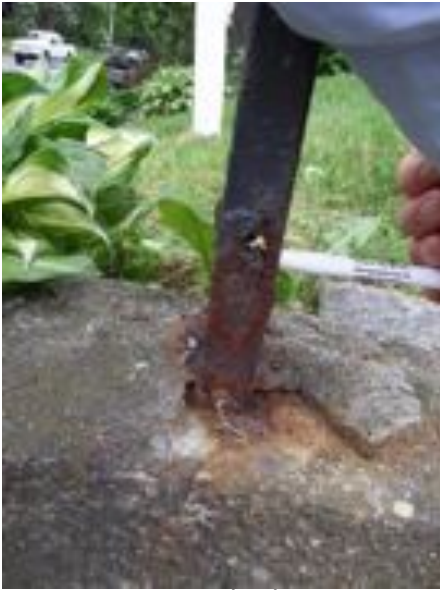
Handrail

05/31/2014 Iron handrail installed on steps of main walk noted in disrepair. Connection to ground is rusty and loose on one side and detached on the other side at top of steps. Railing may fail to support occupants and may lead to personal injury. Recommend hiring a qualified contractor to repair as necessary.

Iron handrail installed on steps of main walk noted in disrepair. Connection to ground is rusty and loose on one side and detached on the other side at top of steps. Railing may fail to support occupants and may lead to personal injury. Recommend hiring a qualified contractor to repair as necessary.

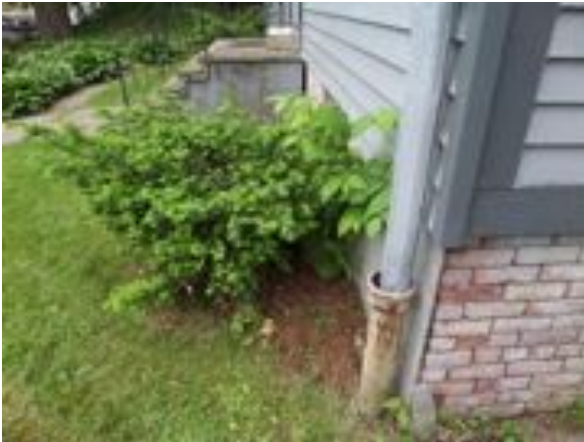
Shrub

05/29/2014 Shrubs observed in close proximity to building. Shrubs too close to house may provide refuge and possible entry for moisture and vermin. Recommend pruning or relocating shrubs so there is at least a 1 foot space between shrubs and siding.

Shrubs observed in close proximity to building. Shrubs too close to house may provide refuge and possible entry for moisture and vermin. Recommend pruning or relocating shrubs so there is at least a 1 foot space between shrubs and siding.

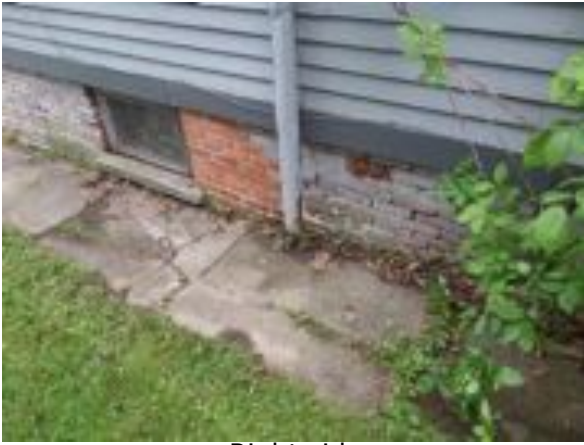
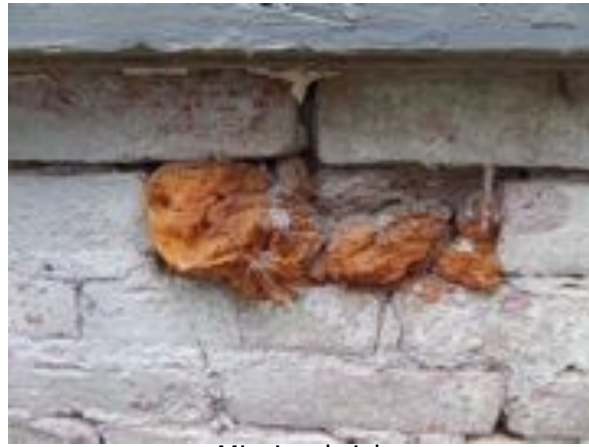
Right side

Brick foundation walls observed in need of repair. Missing mortar, cracked/missing/incomplete bricks noted. This condition may allow the elements in which may cause further deterioration. Recommend hiring a qualified mason to repoint or repair as necessary.

Missing brick

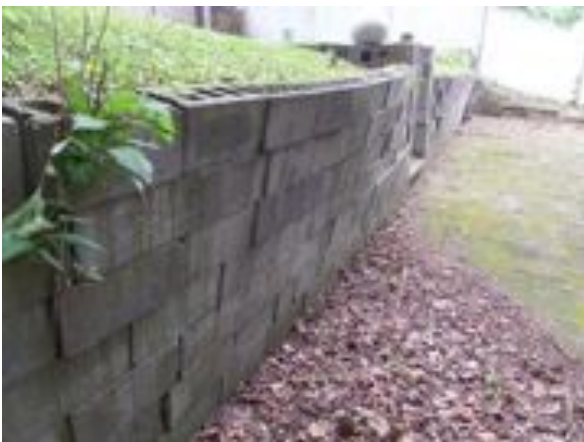
Retaining wall holding backyard soil away from home noted bulging. If not attended to, retaining wall may eventually collapse. Recommend hiring a qualified masonry contractor to repair as necessary.

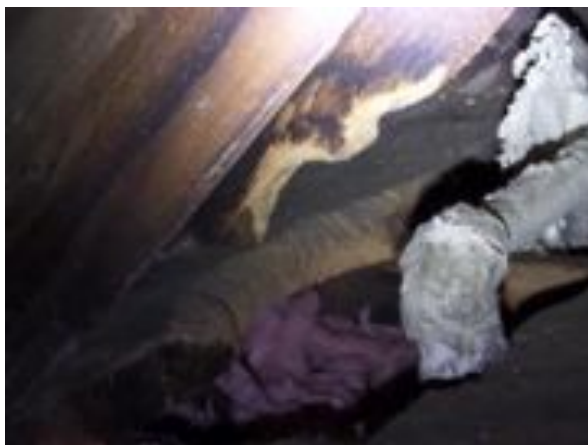
Attic

05/30/2014 Asbestos-like material noted in knee-wall area of attic in the form of pipe wrap. Material looks like it may be friable. Asbestos may cause serious health problems when inhaled. It is recommended that a qualified asbestos testing/abatement contractor be hired to evaluate material and condition.

Asbestos-like material noted in knee-wall area of attic in the form of pipe wrap. Material looks like it may be friable. Asbestos may cause serious health problems when inhaled. It is recommended that a qualified asbestos testing/abatement contractor be hired to evaluate material and condition.

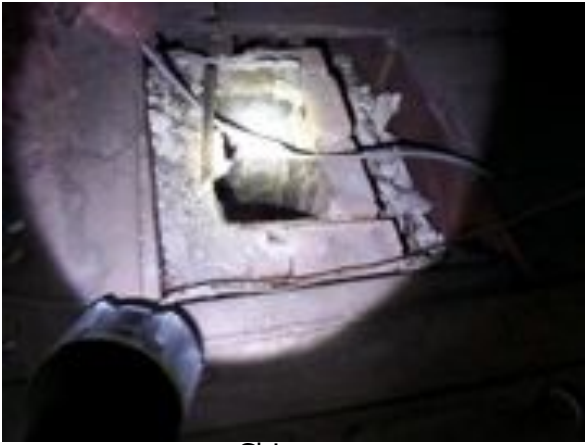
Chimney

05/30/2014 Decommissioned fireplace chimney noted creating an unsafe condition in attic. It appears chimney has been disassembled down to attic floor height and left open. This opening may be cause for injury or allow objects/vermin to fall within. Recommend hiring a qualified contractor to repair as necessary.

Decommissioned fireplace chimney noted creating an unsafe condition in attic. It appears chimney has been disassembled down to attic floor height and left open. This opening may be cause for injury or allow objects/vermin to fall within. Recommend hiring a qualified contractor to repair as necessary.

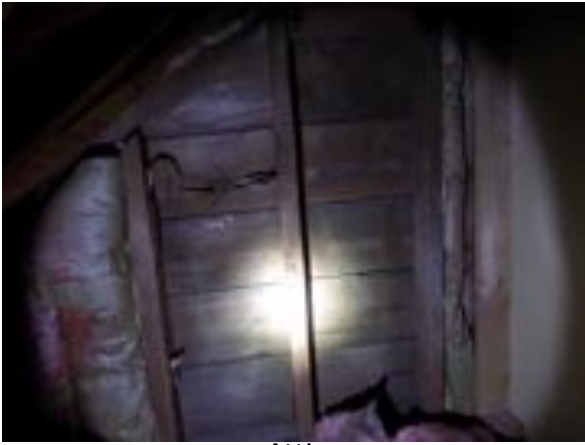
Attic

05/30/2014 Fiberglass batt insulation noted missing or displaced in multiple areas of attic roof. Missing insulation may compromise thermal envelope and allow heat to escape living area. Recommend hiring a qualified contractor to repair as necessary.

Fiberglass batt insulation noted missing or displaced in multiple areas of attic roof. Missing insulation may compromise thermal envelope and allow heat to escape living area. Recommend hiring a qualified contractor to repair as necessary.

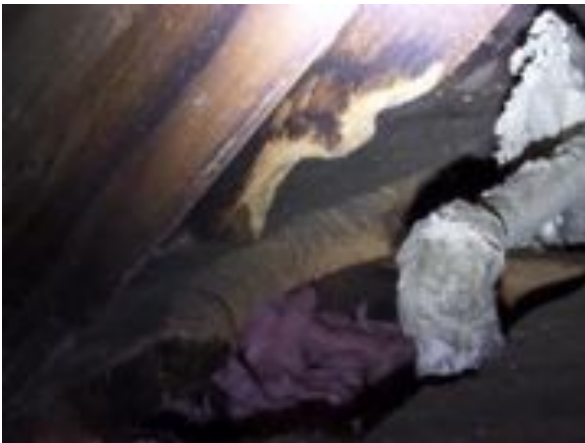
Attic

Evidence of vermin intrusion found in attic area. Chewed/scratched wood noted in several areas. Even though no animals were found in attic at time of inspection, it is recommended to monitor attic areas for signs of vermin intrusion.

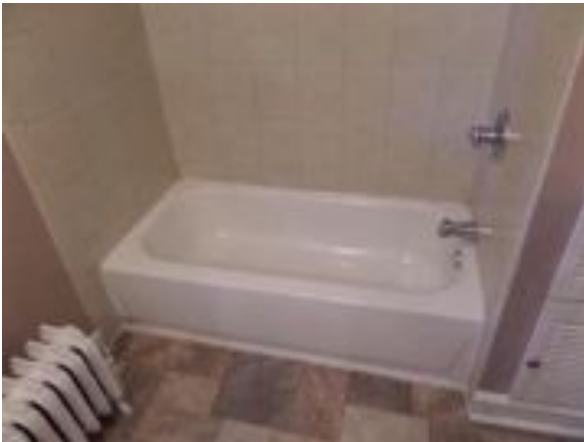
Main bathroom

05/30/2014 1 of 2 outlets was not GFCI protected. It is standard building practice to install GFCI outlets for use in bathrooms or wherever a water source is present. Without a GFCI outlet installed occupants may be at a higher risk of electric shock. Recommend hiring a qualified electrical contractor to repair as necessary.

1 of 2 outlets was not GFCI protected. It is standard building practice to install GFCI outlets for use in bathrooms or wherever a water source is present. Without a GFCI outlet installed occupants may be at a higher risk of electric shock. Recommend hiring a qualified electrical contractor to repair as necessary.

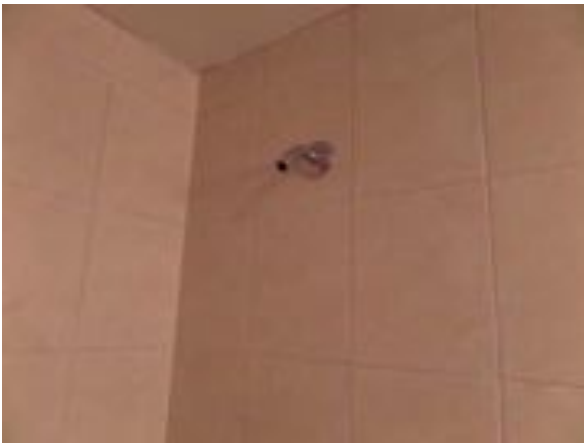
Shower head appeared to be missing at time of inspection.

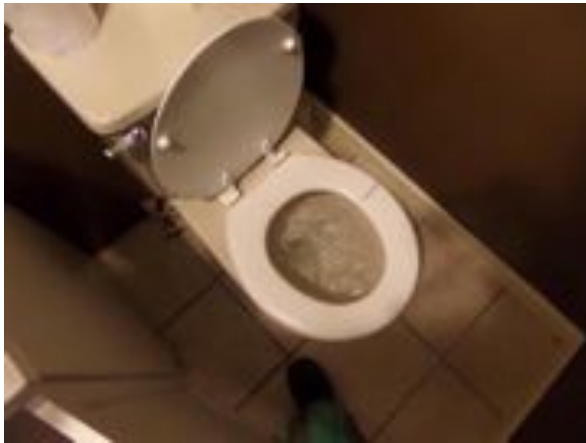
05/30/2014 Toilet seat observed as cracked at time of inspection. Cracked toilet seat may pinch or break. Recommend replacing toilet seat.

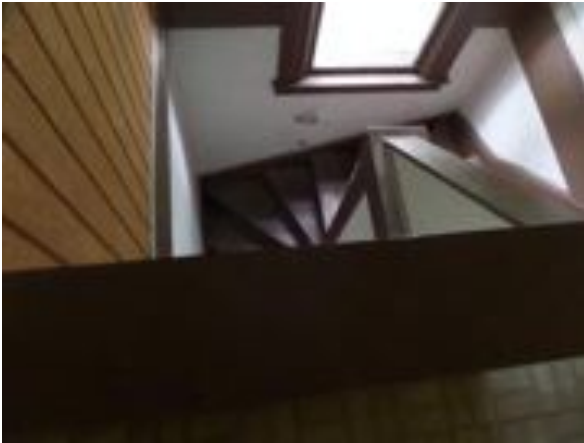
Stair left

05/30/2014 No handrail was noted installed on winding rear staircases at time of inspection. Lack of a handrail may increase risk of fall and is therefore a safety hazard. Recommend installing handrail by qualified contractor.

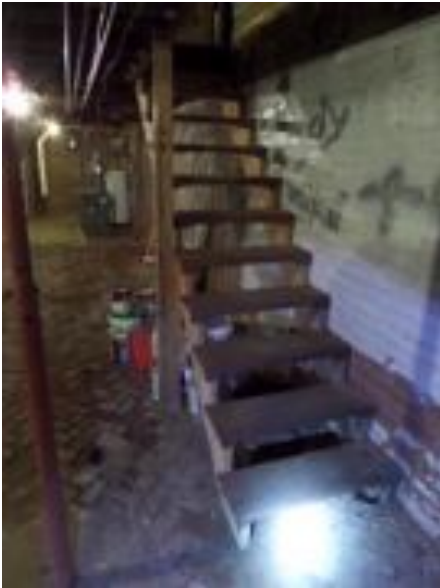
Basement stair

05/30/2014 No handrail was noted installed on either side basement stairs at time of inspection. Lack of a handrail may increase risk of fall and is therefore a safety hazard. Recommend installing handrail by qualified contractor.

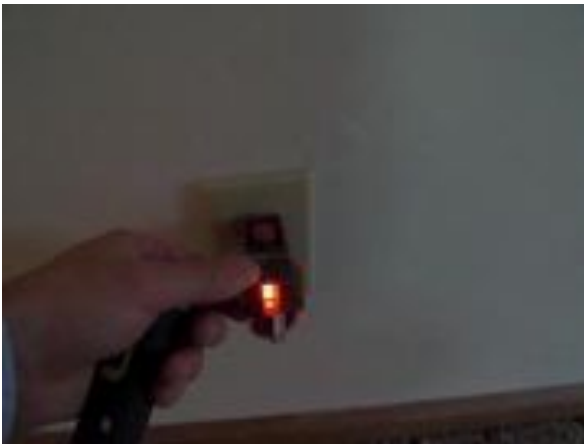
Outlet

05/30/2014 Multiple outlets on the 142 side were observed as not grounded properly. Improperly grounded outlets may lead to risk of electric shock and/or fire. Recommend hiring a qualified electrical contractor to repair as necessary.

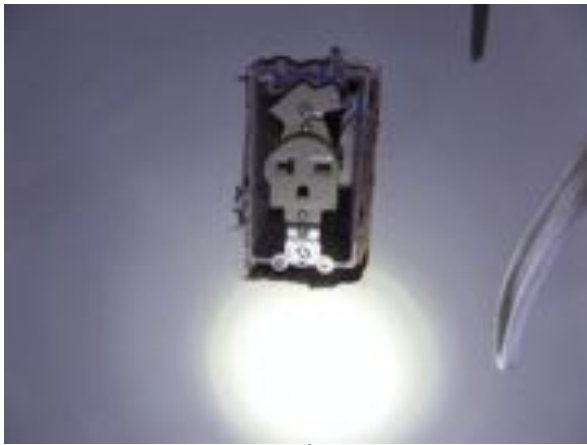
Outlet

05/30/2014 Many switch/receptacle cover plates throughout the house noted broken or missing. Missing covers may not cover live wiring adequately which could lead to electric shock or fire. Recommend replacing broken or missing cover plates as necessary.

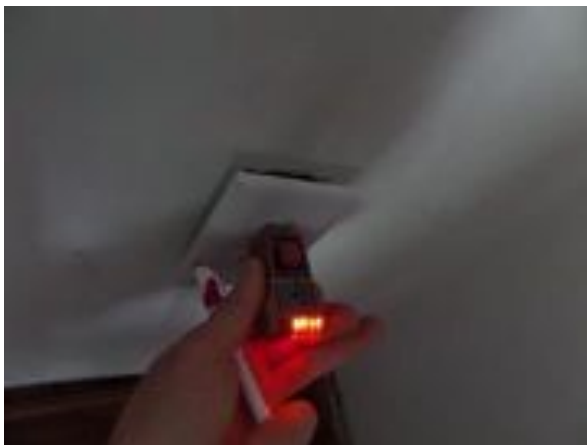
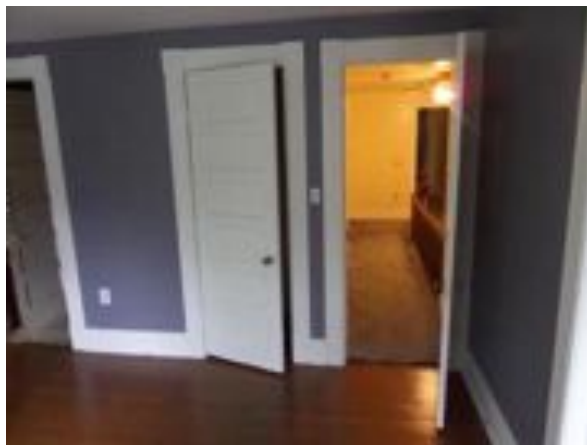
05/30/2014 Loose outlet noted in closet on second floor. Outlet is not firmly attached to wall and pulls out when unplugging a device. A loose outlet may pose a risk of electric shock or fire. Recommend hiring a qualified electrical contractor to repair as necessary.

Loose outlet noted in closet on second floor. Outlet is not firmly attached to wall and pulls out when unplugging a device. A loose outlet may pose a risk of electric shock or fire. Recommend hiring a qualified electrical contractor to repair as necessary.

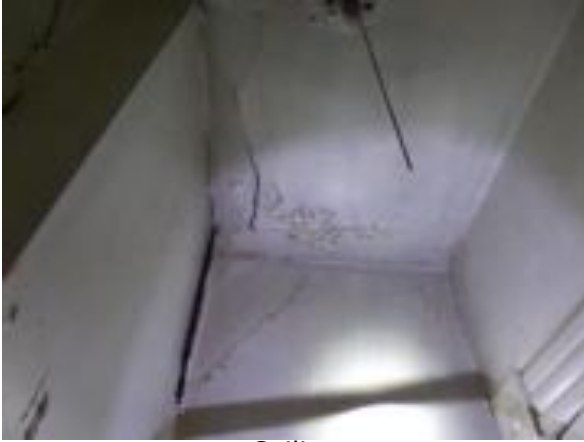
Ceiling

05/30/2014 Cracked or missing plaster noted on ceilings and walls in several areas throughout the house. Recommend hiring a qualified contractor to repair as necessary.

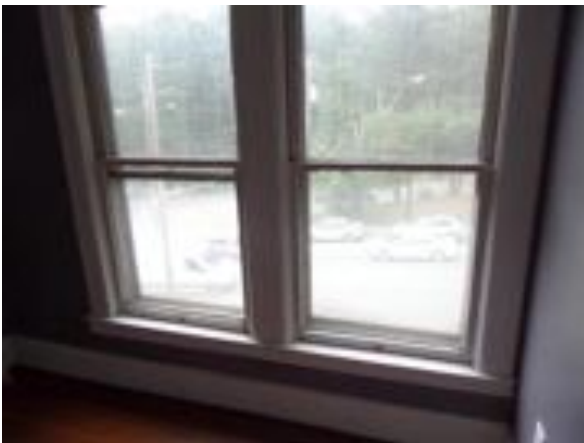
Windows

05/30/2014 Several windows were noted with missing or inoperable locks. Without functioning window locks, the home is easier to break into to. Recommend installing lock on all windows to increase home security.

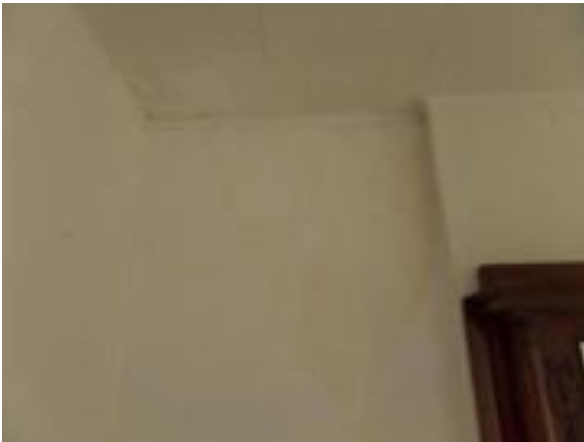
1st floor wall

05/30/2014 Moisture staining noted on ceiling and walls on 142 side. The cause of the staining was not determined at time of inspection. Recommend monitoring these area for changes or presence of moisture.

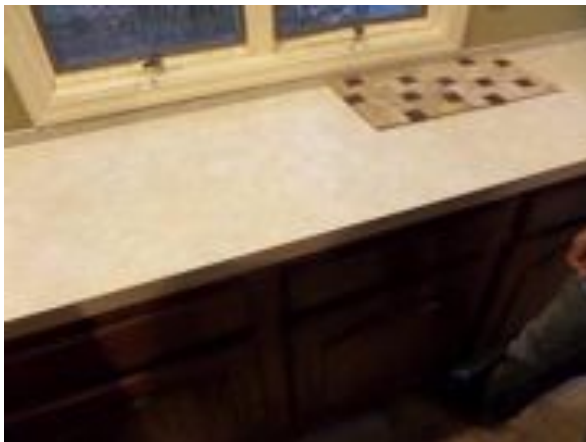
Kitchen counter

05/30/2014 Counter top did not seem to be securely fastened to cabinets. This may allow for movement of countertop, pinching, or other injury. Recommend hiring a qualified contractor to repair as necessary.

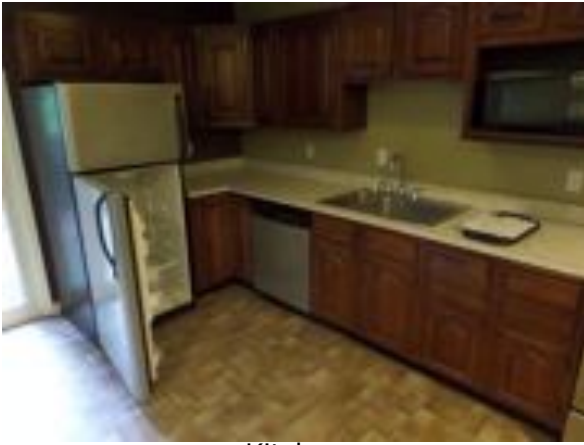
Kitchen

05/30/2014 Some of the cabinet hardware was loose or missing. Cabinetry may not function as designed. Recommend repair by qualified contractor.

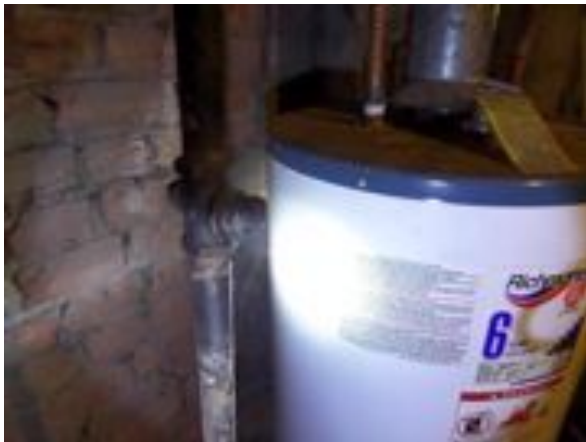
Water heater

Safety extension for TPR valve was not installed. A safety extension is designed to carry hot water safely to the ground in the event of an over pressurization. Without a safety extension occupants may be at risk of burning or other injury during an over pressurization. Recommend hiring a qualified plumbing contractor to repair as necessary.

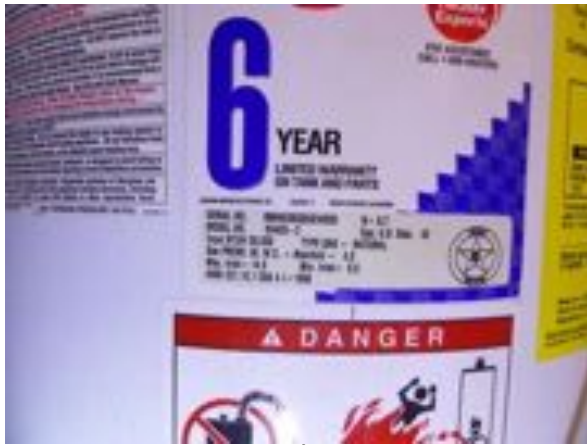
Water heater

No drip leg was noted installed on the gas supply line to the water heater. A drip leg is a device used to trap impurities in the gas line. A gas line without a drip leg may cause improper function of the gas appliance which may be hazardous. Recommend a qualified plumbing contractor repair as necessary.

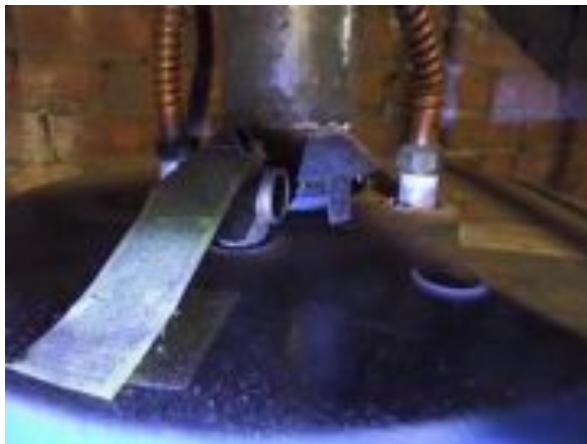
05/30/2014 Water heater flue was observed improperly sealed where it meets the chimney. This condition is unsafe as it may allow harmful gases to enter the basement. Recommend repair as necessary by qualified contractor.

Water heater flue was observed improperly sealed where it meets the chimney. This condition is unsafe as it may allow harmful gases to enter the basement. Recommend repair as necessary by qualified contractor.

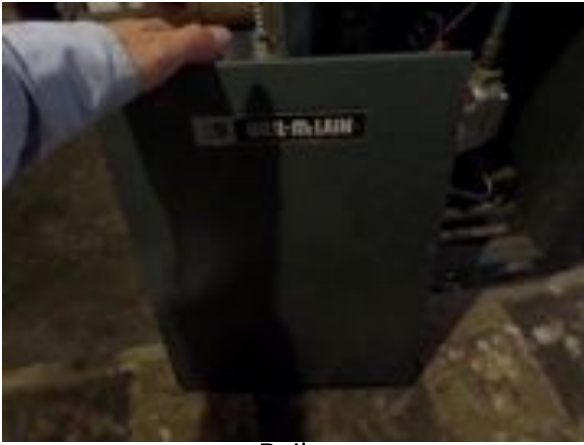
Boiler

05/30/2014 No safety extension on boiler noted at time of inspection. Safety extension is designed to carry hot water away from TPR Valve to the floor in the event of an over pressurization. Without safety extension occupants may be at risk of burning or other injury if an over pressurization occurs. recommend hiring a qualified plumbing contractor to repair as necessary.

No safety extension on boiler noted at time of inspection. Safety extension is designed to carry hot water away from TPR Valve to the floor in the event of an over pressurization. Without safety extension occupants may be at risk of burning or other injury if an over pressurization occurs. recommend hiring a qualified plumbing contractor to repair as necessary.

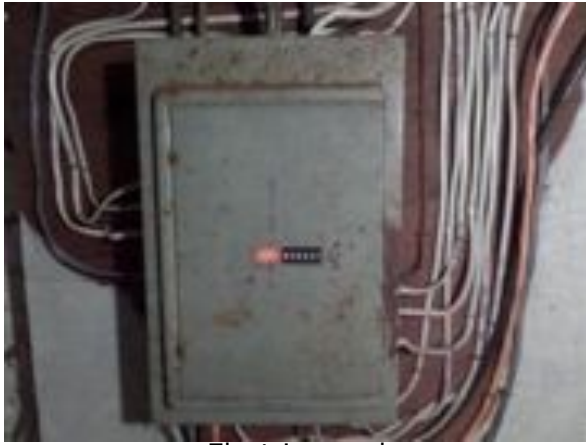
Electric panel

05/31/2014 Rust noted on outside of electric panel. Although no rust was found inside electric panel at time of inspection, panel cover was noted with rust. Rust is an indication of the presence of moisture. Moisture can cause concern for safety when combined with electricity. Recommend hiring a qualified electrical contractor to evaluate safety of electrical panel.

Rust noted on outside of electric panel. Although no rust was found inside electric panel at time of inspection, panel cover was noted with rust. Rust is an indication of the presence of moisture. Moisture can cause concern for safety when combined with electricity. Recommend hiring a qualified electrical contractor to evaluate safety of electrical panel.

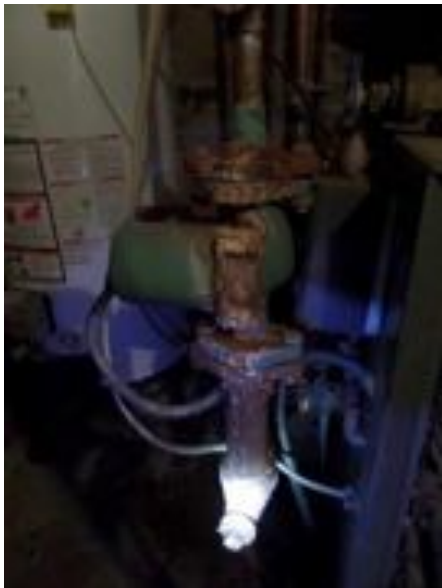
142 side Boiler noted in poor condition. Rust and/or corrosion was observed in several areas including the circulator pump and surrounding plumbing. An active leak was noted in plumbing exiting boiler. A ticking noise was observed as well. Additionally, heat was not received on the third floor. Recommend hiring a qualified HVAC contractor to assess the condition of the boiler and estimate the needed repairs which may cost \$1500 or more.

Rust/Corrosion

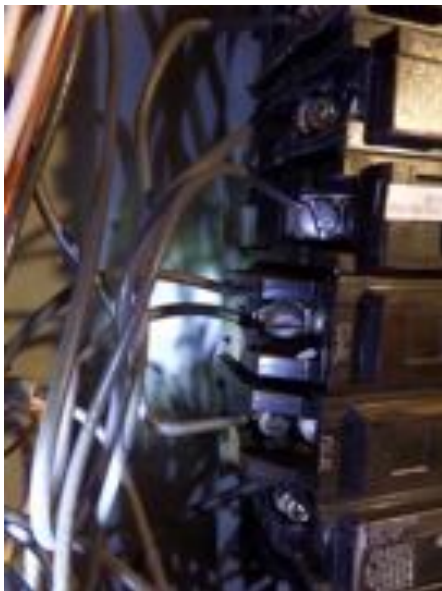
05/30/2014 One double tapped breaker was found at time of inspection. Double tapped breakers are a safety concern as they pose a risk of micro-arcing which may lead to fire. Recommend hiring a qualified electrical contractor to repair as necessary.

Double tap
