██████████
██████████ Pawling Ave
Troy, 12180
HIN™: 121806288
Email: ██████████
Inspection Date: 05-28-2014

Hollis Home Inspection
J Hollis Allison
199 Green st Hudson, New York 12534
Phone: (518) 421-6069
E-Mail: hollishomeinspection@gmail.com

Welcome and thank you for choosing Hollis Home Inspection.
 This report is designed to be as thorough as possible, but also clear and concise.
 If you have any questions please call us at (518) 421-6069

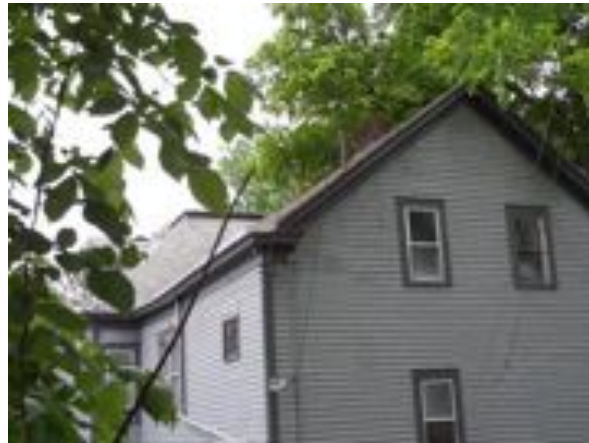
Trees

Moss noted on asphalt shingles. This can lead to deterioration of roof decking due to water being leached under the shingles by the moss. Recommend a qualified contractor repair as necessary.

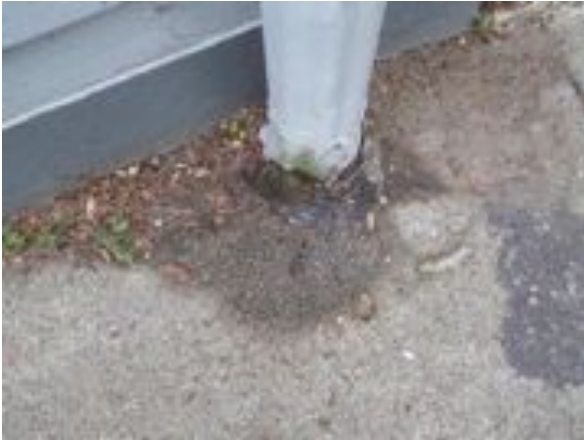
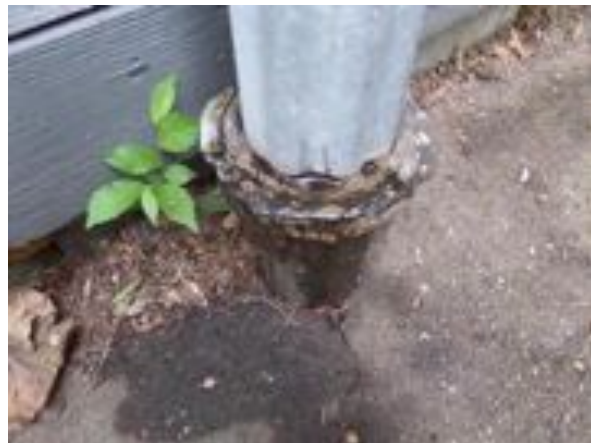
More than one downspout appeared to have burst. This is likely due to clogging and freezing of downspouts. Downspouts no longer seem to be watertight. This may allow moisture to escape downspout before it is carried away from the house. Recommend hiring a qualified contractor to repair as necessary.

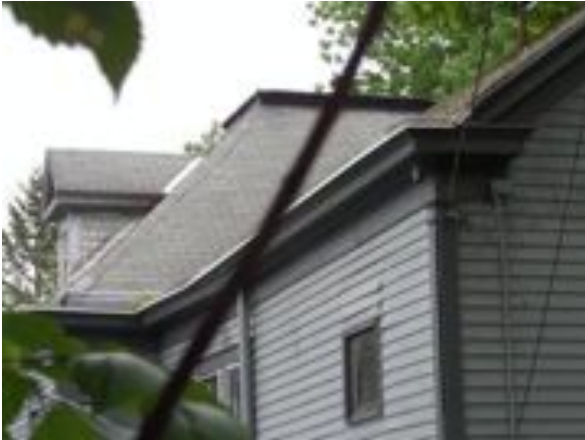
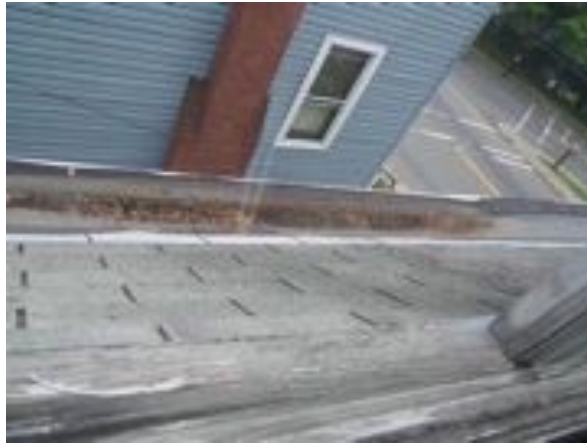
Gutters appear to be retaining debris. Debris can clog gutters which may impede or retard roof drainage. Recommend clearing debris from gutters to promote roof drainage.

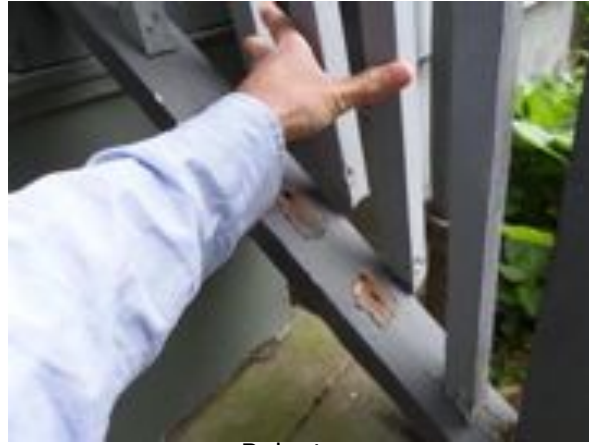
05/29/2014 144 side porch steps noted with detached balusters. Balusters are designed to safely guard occupants from injury. Detached balusters may become detached, may pinch or otherwise injure occupants, or may fail to perform as designed. Recommend hiring a qualified contractor to repair as necessary.

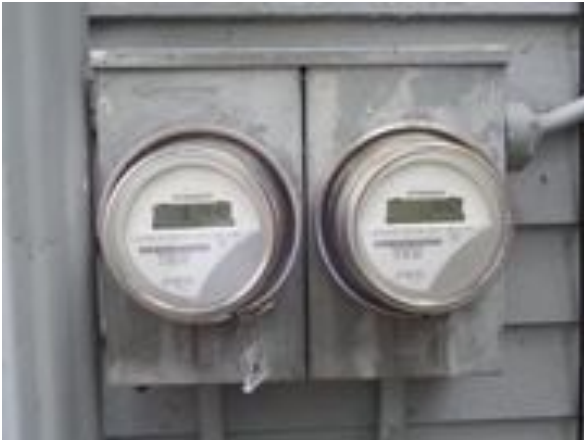
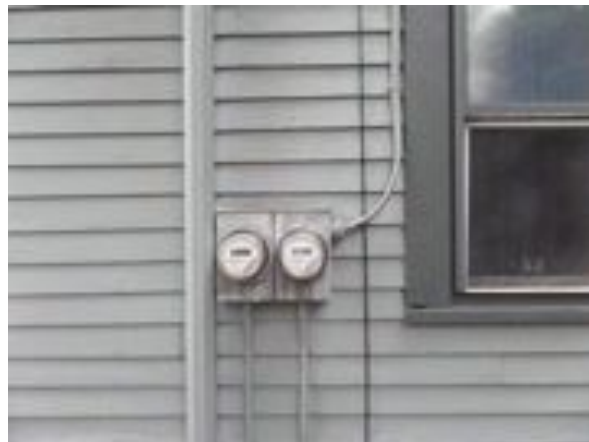
Electric service drop wire may be undersized. Service drop wire appear to be a gauge rated for 150 amps if made of aluminum. Service wire splits within meter housing to serve each 100 amp electric panel serving each unit. If a combined draw of more than 150 amps is called for between the two units simultaneously, service wire may be overloaded. This may cause a risk of fire. Recommend hiring a qualified electrical contractor to determine safety of service drop and repair as necessary.

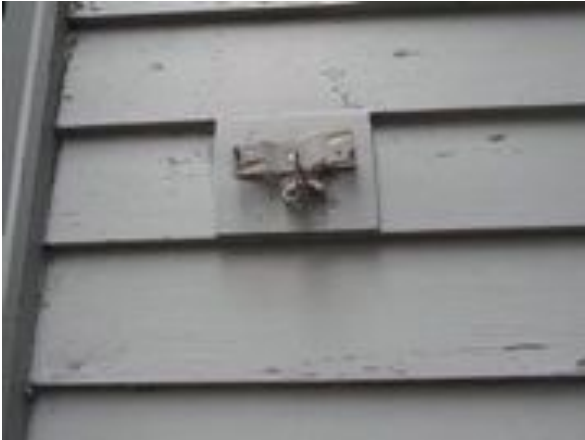
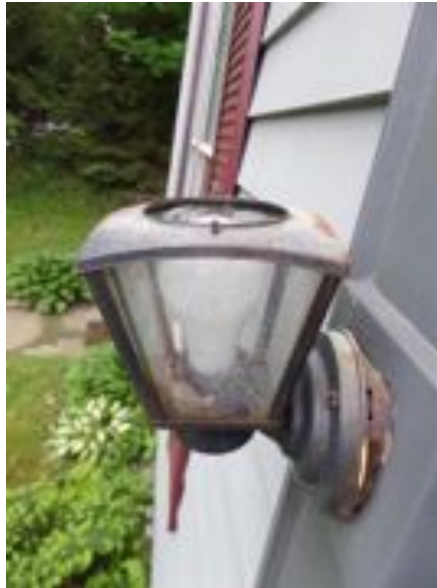
Exterior light fixtures noted in unsafe condition. Exposed wires, loose and unsealed fixtures may cause electric shock or fire. Recommend hiring a qualified electrician to repair as necessary.

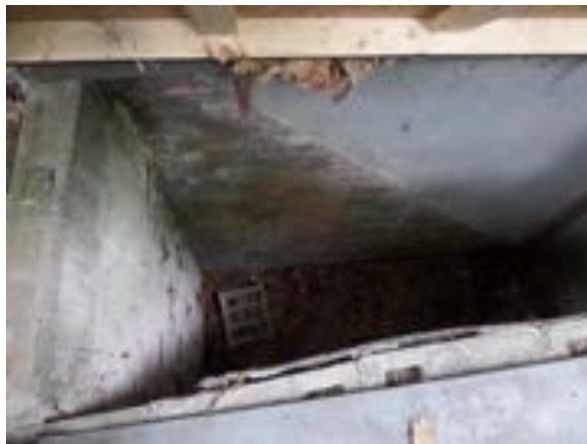
Opening

05/29/2014 Hatch covering cavity for basement stairs (which may have previously existed) noted as not secure. Hatch could be opened creating a potential for fall or other injury. This condition may allow entry of unwanted pests or burglars. Additionally, this uninsulated opening may allow air infiltration and reduce thermal efficiency. Recommend hiring a qualified contractor to repair as necessary.

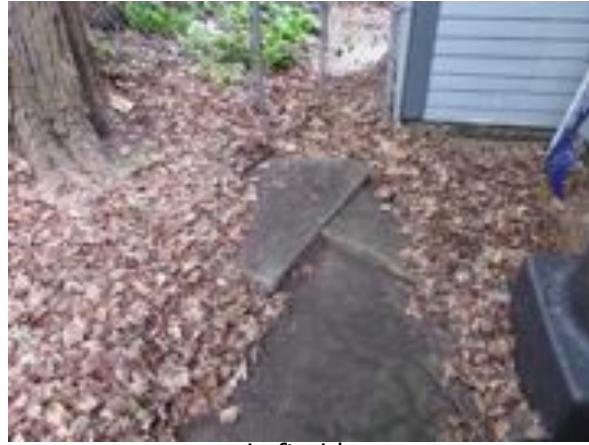
Left side

05/29/2014 Walkway on left side of house appeared heaved. This may be due to tree roots pushing from underneath. Uneven and non-level walk may pose a trip/fall hazard to occupants. Recommend hiring a qualified contractor to repair as necessary.

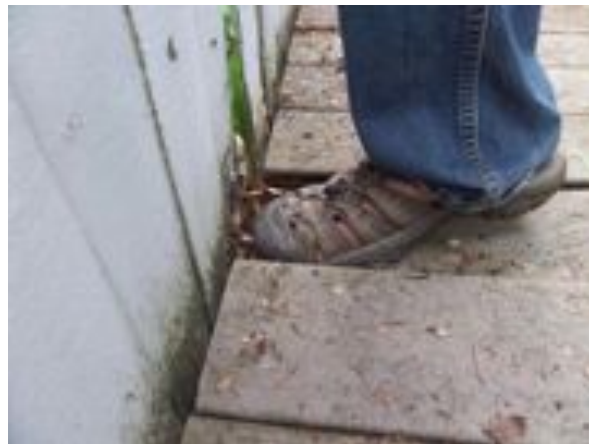
05/29/2014 Ramp on right side of building observed in unsafe condition. Decking member seen protruding above surface creating a potential trip hazard. Board ends observed spongy and unsupported on fence side which may pinch or fail to support occupants. Structure underneath ramp was not visible so structural integrity could not be verified. Recommend hiring a qualified contractor to repair as necessary.

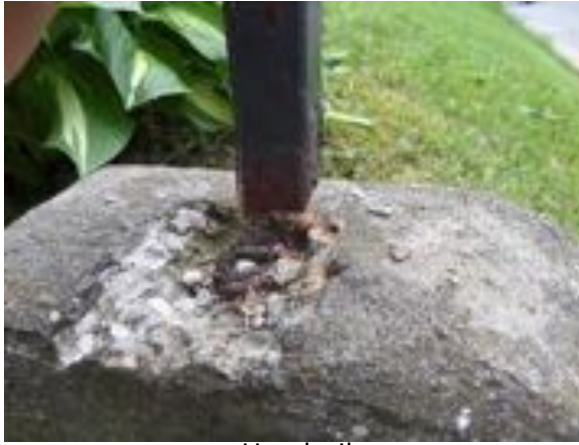
Handrail

05/31/2014 Iron handrail installed on steps of main walk noted in disrepair. Connection to ground is rusty and loose on one side and detached on the other side at top of steps. Railing may fail to support occupants and may lead to personal injury. Recommend hiring a qualified contractor to repair as necessary.

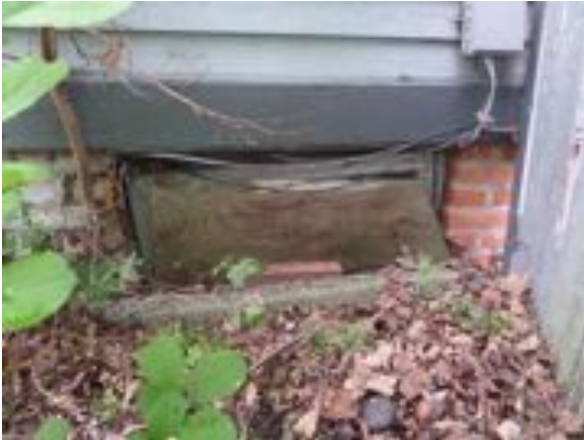
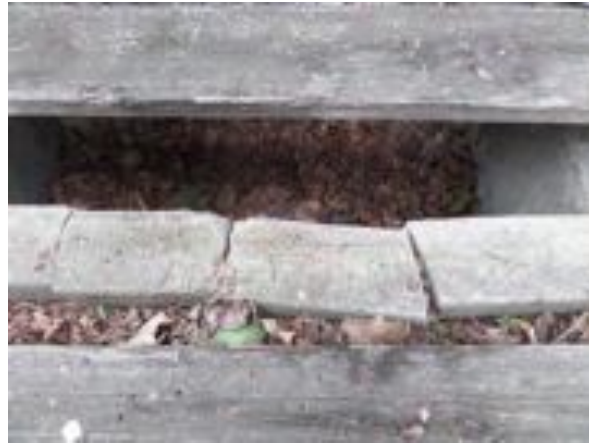
Multiple concrete basement window wells noted in need of repair. Cracked masonry may not effectively keep moisture from entering the windows/basement. Recommend hiring a qualified masonry contractor to repair as necessary.

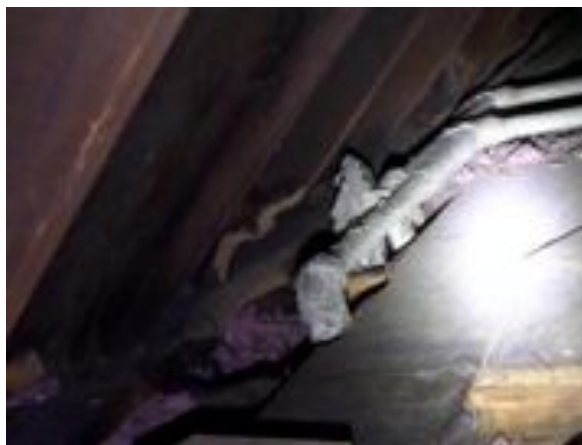
Pipes

05/30/2014 Asbestos-like material noted in knee-wall area of attic in the form of pipe wrap. Material looks like it may be friable. Asbestos may cause serious health problems when inhaled. It is recommended that a qualified asbestos testing/abatement contractor be hired to evaluate material and condition.

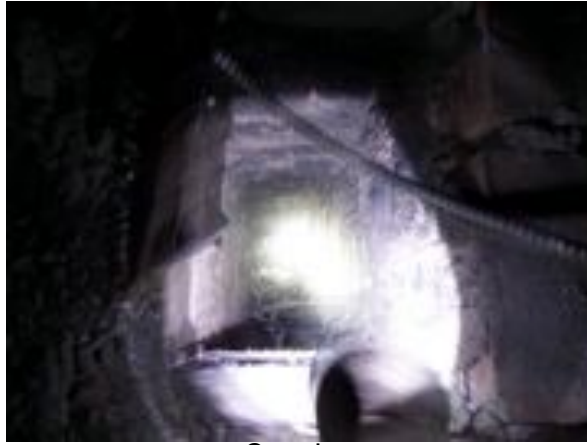
Opening

05/30/2014 Decommissioned fireplace chimney noted creating an unsafe condition in attic. It appears chimney has been disassembled down to attic floor height and left open. This opening may be cause for injury or allow objects/vermin to fall within. Recommend hiring a qualified contractor to repair as necessary.

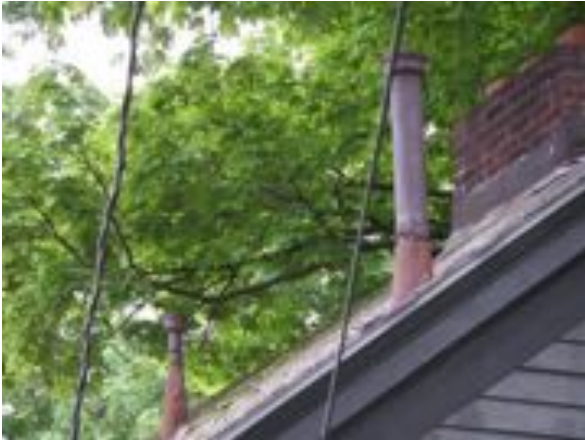
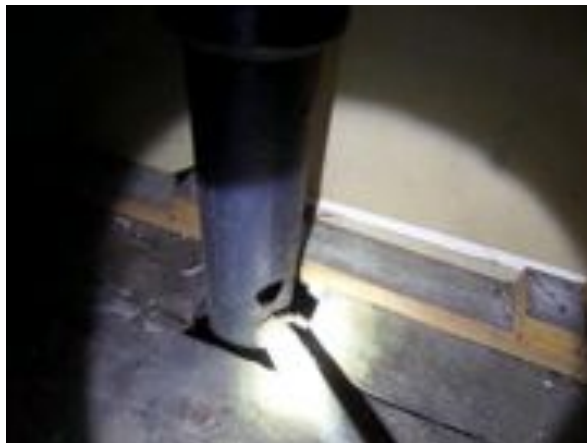
Cast iron plumbing vent pipe in attic noted in disrepair. Pipe joint is compromised allowing sewer gasses to enter the attic space. Sewer gasses may be harmful to occupants. Recommend hiring a qualified plumbing contractor to repair as necessary.

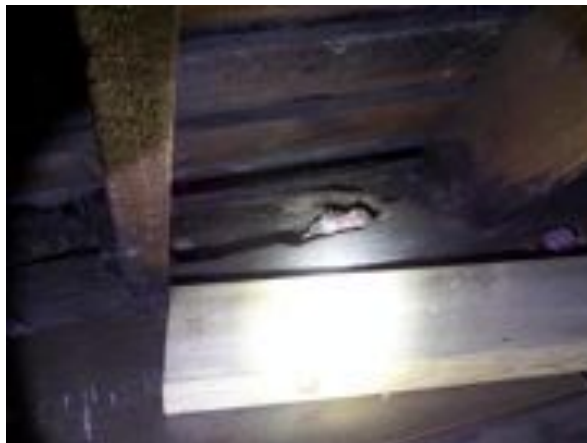
Attic

05/30/2014 No leaks were detected in attic area at time of inspection.

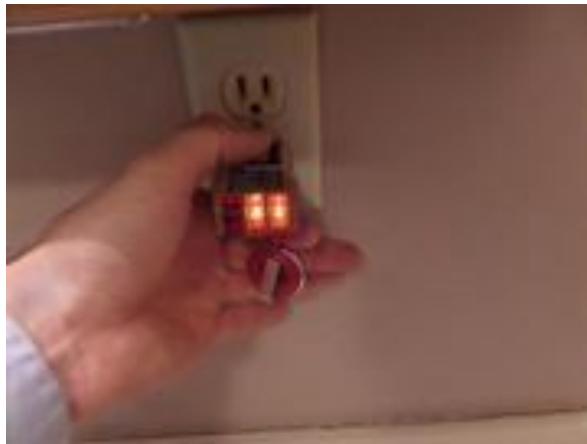
Receptacle

1 of 2 outlets was not GFCI protected. It is standard building practice to install GFCI outlets for use in bathrooms or wherever a water source is present. Without a GFCI outlet installed occupants may be at a higher risk of electric shock. Recommend hiring a qualified electrical contractor to repair as necessary.

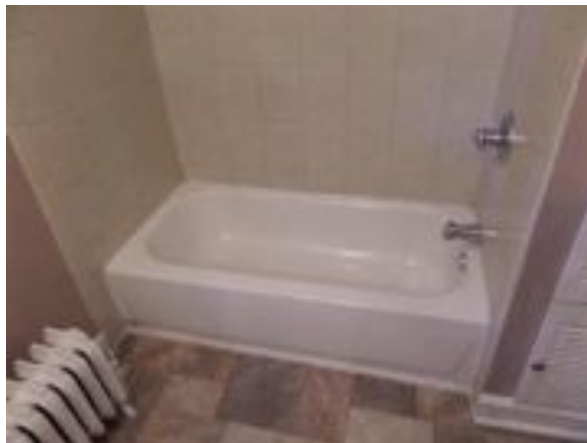
Main bathroom

Shower head appeared to be missing at time of inspection.

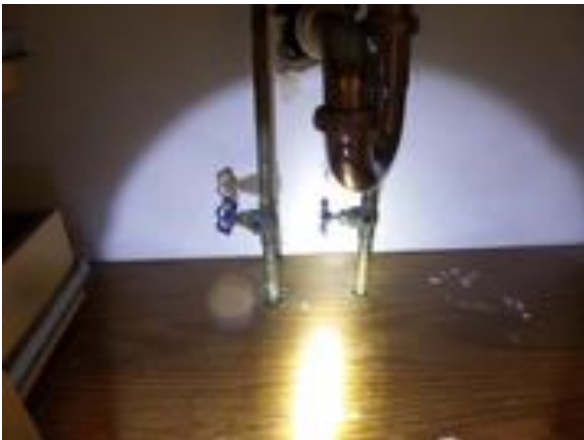
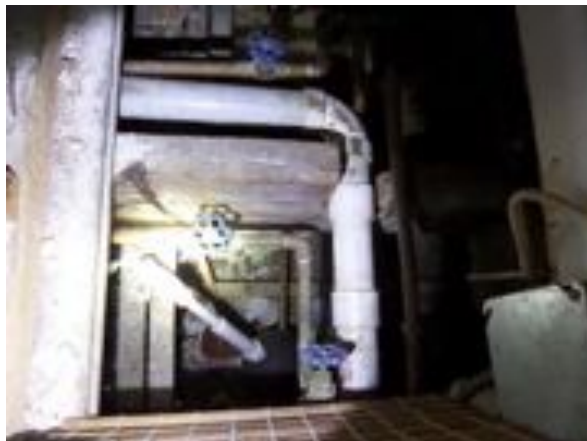
No leaks detected in main bathroom at time of inspection.

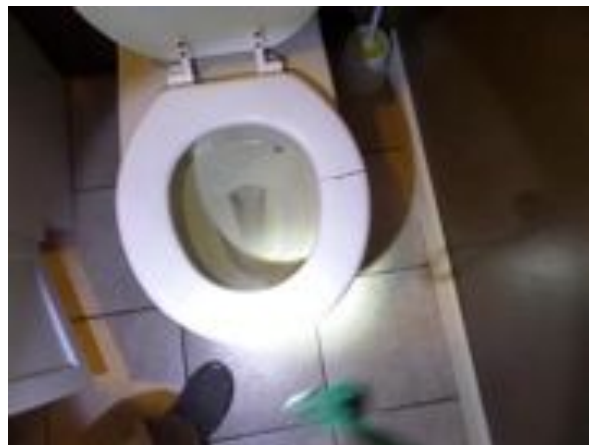
05/30/2014 Toilet seat observed as cracked at time of inspection. Cracked toilet seat may pinch or break. Recommend replacing toilet seat.

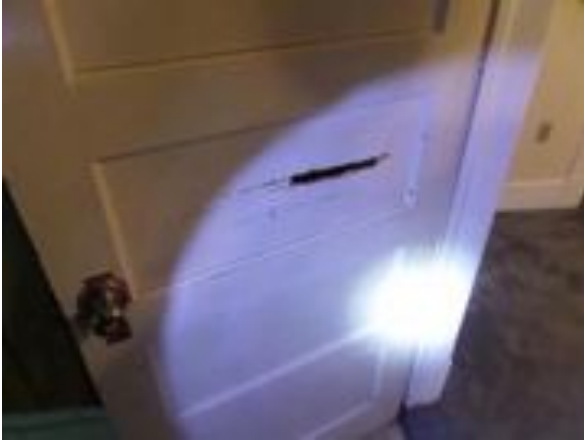
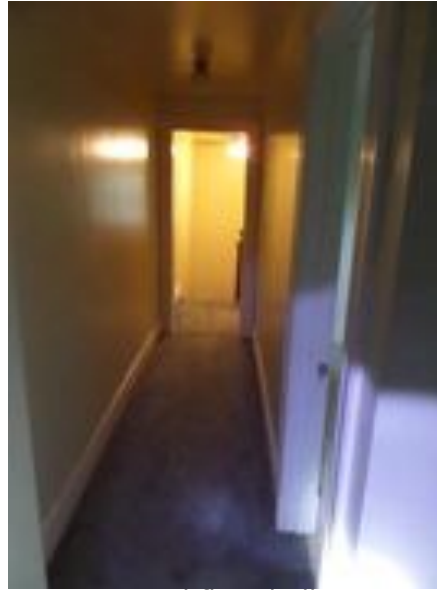
05/30/2014 Wood door panel noted with hole in it. Splintered wood may cause snag or injury. Recommend hiring a qualified contractor to repair as necessary.

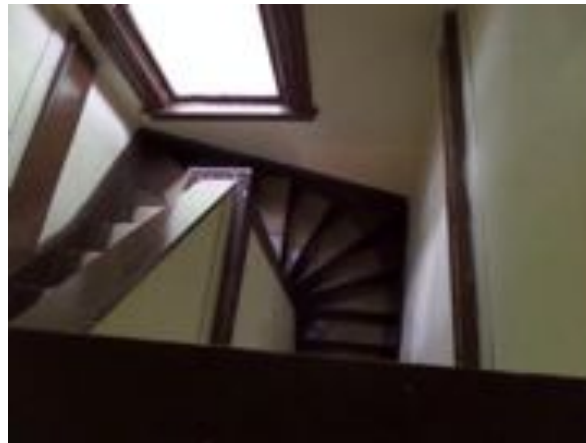
Stair right

05/30/2014 No handrail was noted installed on winding rear staircases at time of inspection. Lack of a handrail may increase risk of fall and is therefore a safety hazard. Recommend installing handrail by qualified contractor.

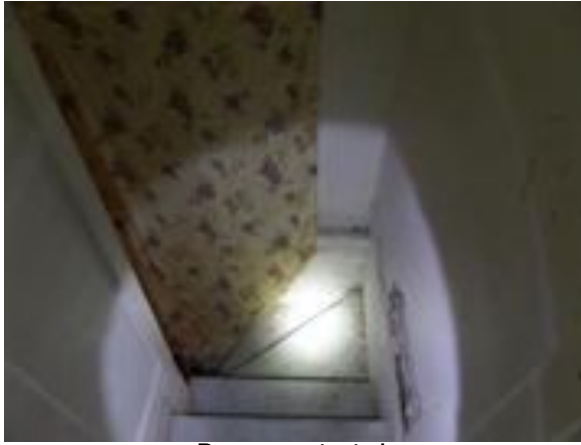
Basement stair

05/30/2014 No handrail was noted installed on either side basement stairs at time of inspection. Lack of a handrail may increase risk of fall and is therefore a safety hazard. Recommend installing handrail by qualified contractor.

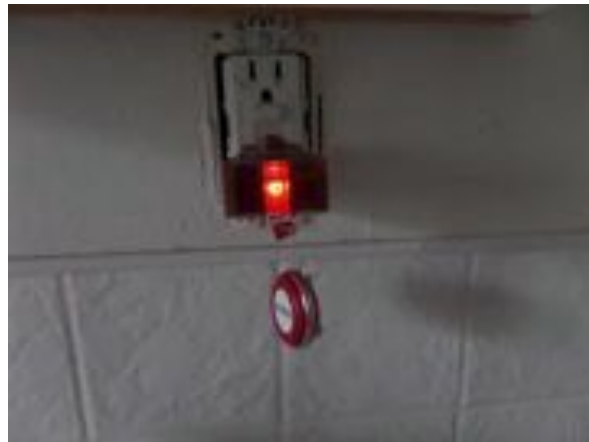
Outlet

05/30/2014 Multiple outlets on the 142 side were observed as not grounded properly. Improperly grounded outlets may lead to risk of electric shock and/or fire. Recommend hiring a qualified electrical contractor to repair as necessary.

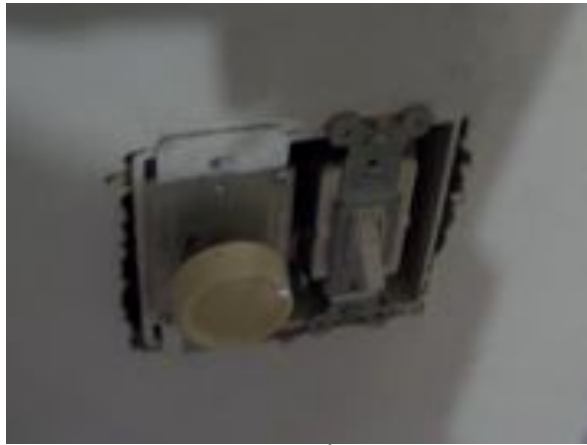
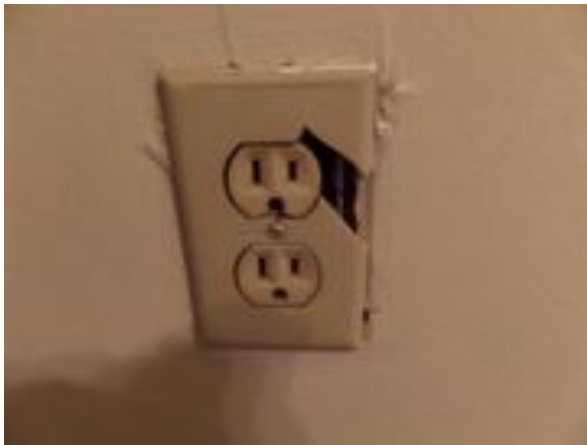
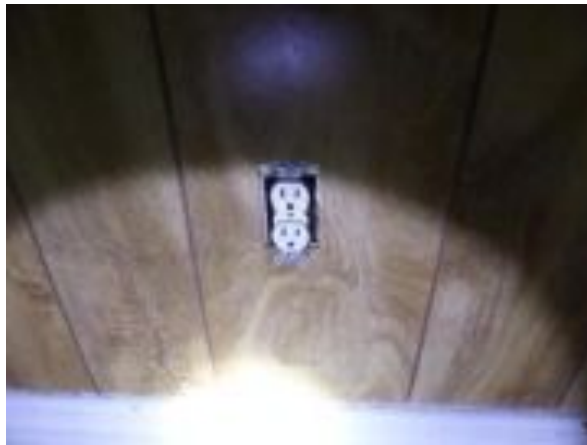
05/30/2014 Many switch/receptacle cover plates throughout the house noted broken or missing. Missing covers may not cover live wiring adequately which could lead to electric shock or fire. Recommend replacing broken or missing cover plates as necessary.

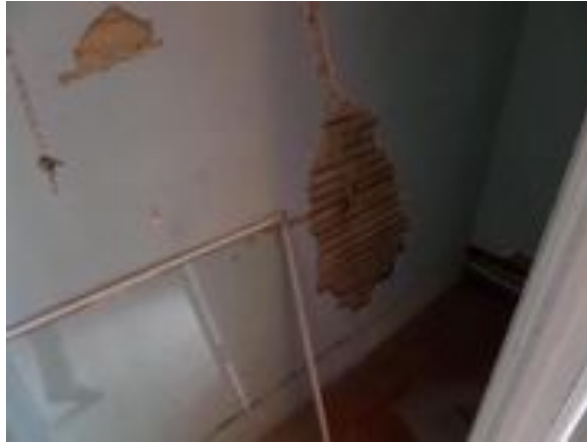
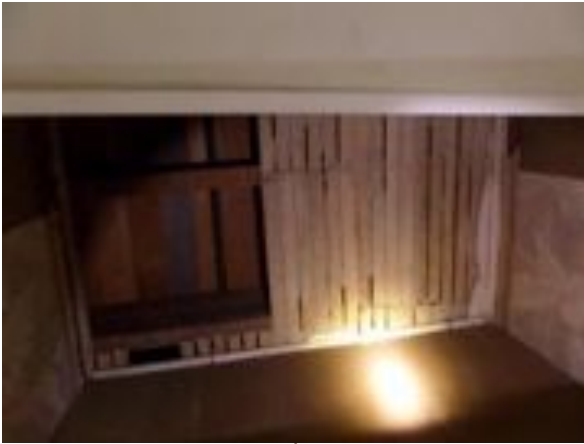
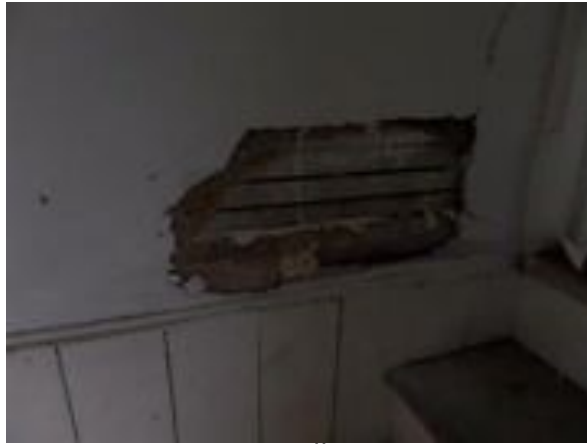
05/30/2014 Cracked or missing plaster noted on ceilings and walls in several areas throughout the house. Recommend hiring a qualified contractor to repair as necessary.

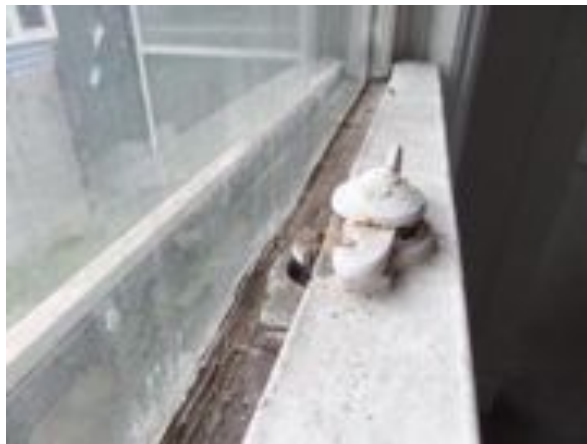
Window

05/30/2014 Several windows were noted with missing or inoperable locks. Without functioning window locks, the home is easier to break into to. Recommend installing lock on all windows to increase home security.

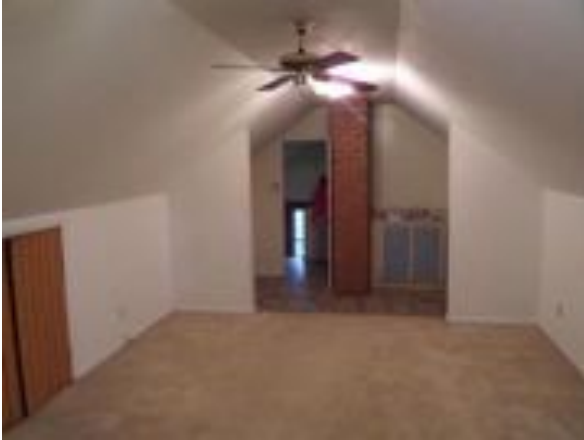
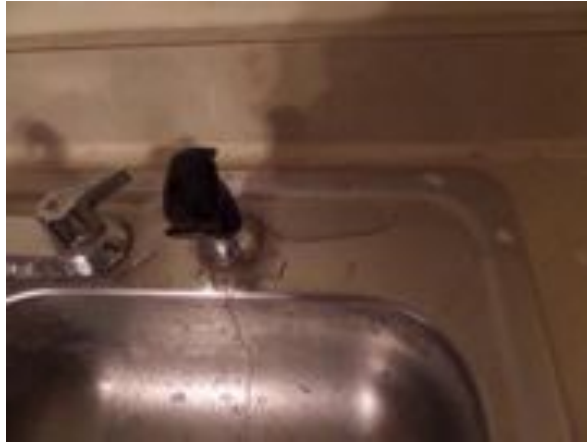
05/30/2014 Sink sprayer on third floor sink noted as leaking. Leaking sprayer may deposit water where it is not wanted and cause damage. Recommend hiring a qualified plumber to repair as necessary.

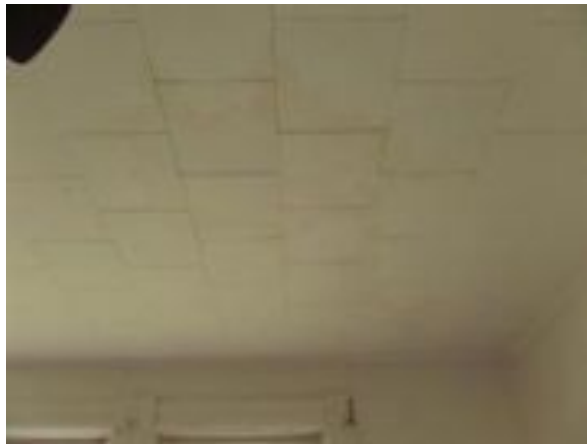
1st floor ceiling

05/30/2014 Moisture staining noted on ceiling and walls on 142 side. The cause of the staining was not determined at time of inspection. Recommend monitoring these area for changes or presence of moisture.

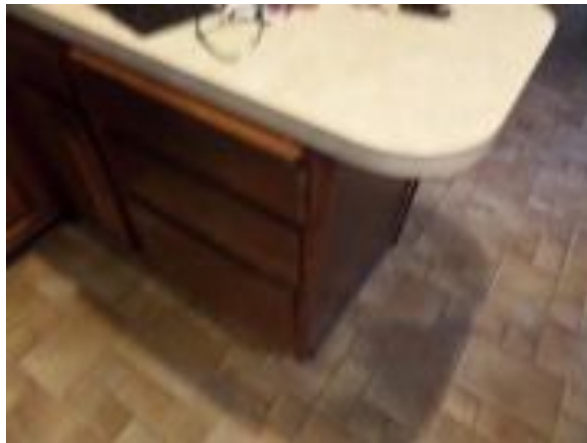
Kitchen counter

05/30/2014 Counter top did not seem to be securely fastened to cabinets. This may allow for movement of countertop, pinching, or other injury. Recommend hiring a qualified contractor to repair as necessary.

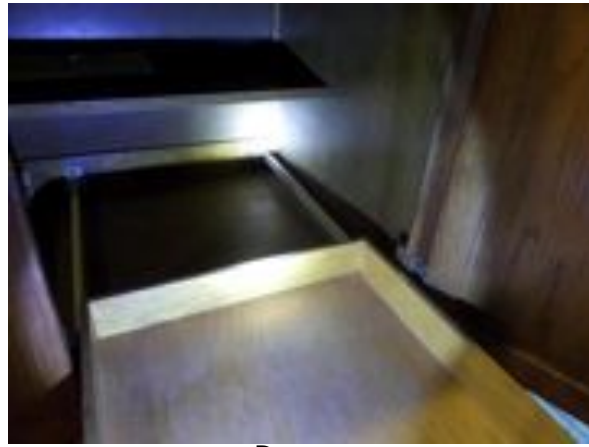
Drawer

05/30/2014 Some of the cabinet hardware was loose or missing. Cabinetry may not function as designed. Recommend repair by qualified contractor.

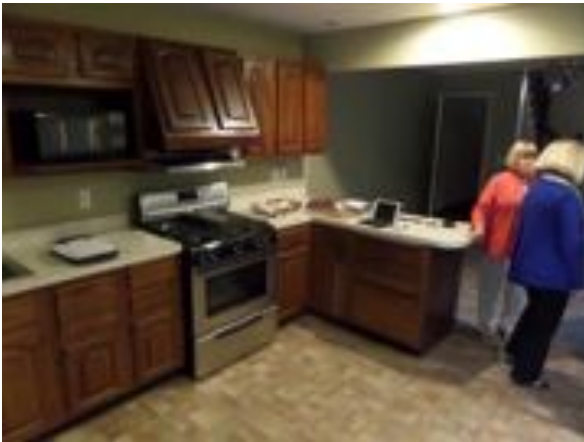
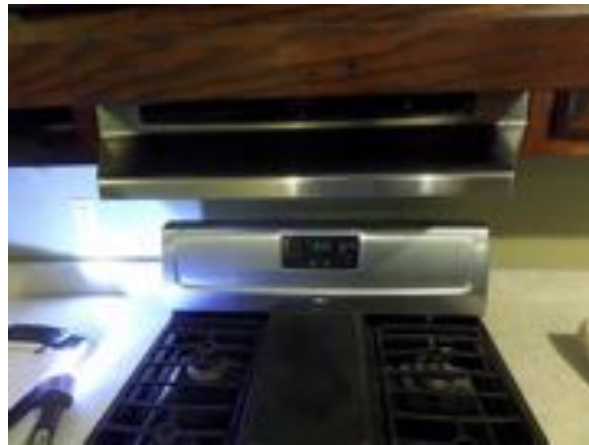
Recirculating vent hood did not seem to function at time of inspection. Without proper ventilation over the stove, moisture may collect and cause damage to the kitchen.

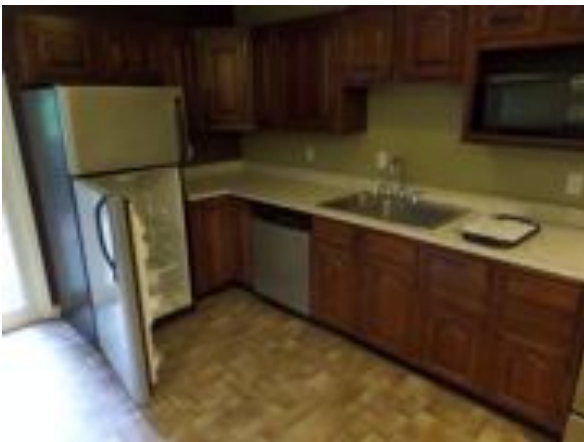
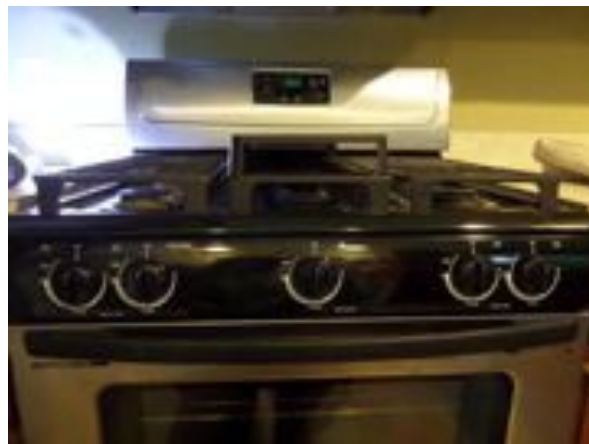
Two of the four burners of the stove did not self ignite.

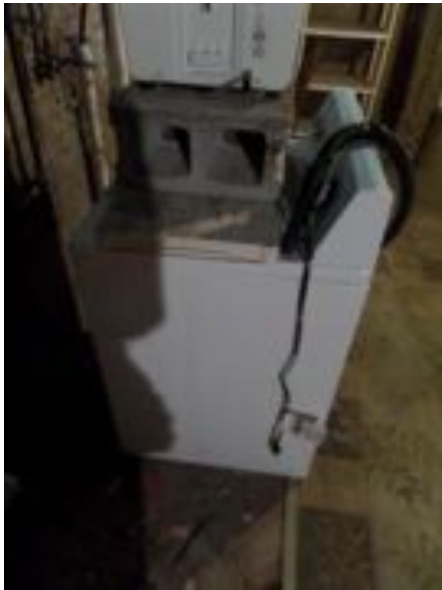
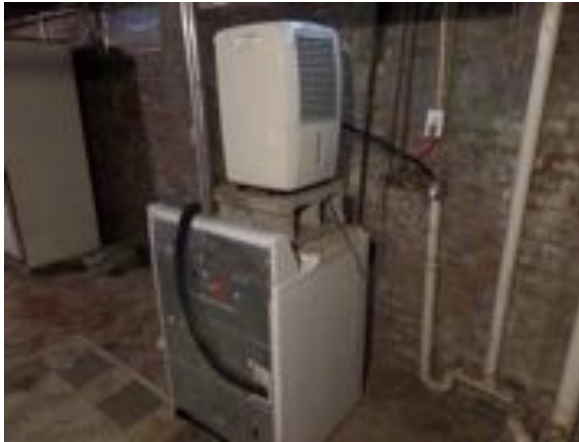
Washing machine was not able to test at time of inspection therefore function of washer could not be determined.

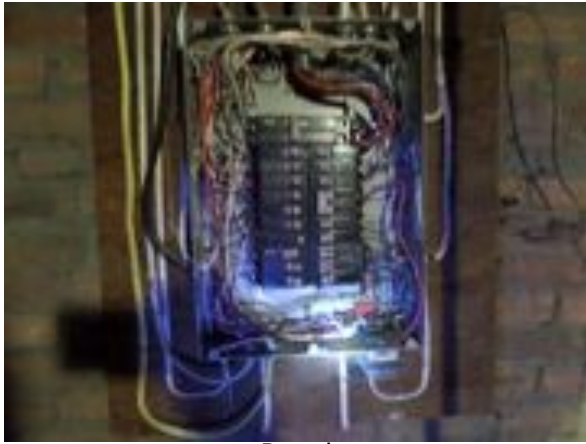
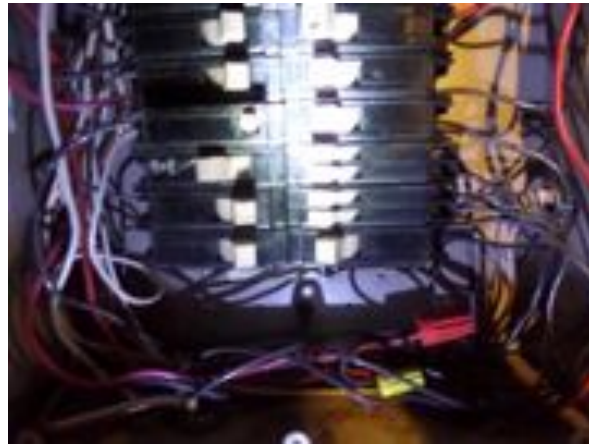
05/31/2014 No defects observed inside electrical panel at time of inspection.

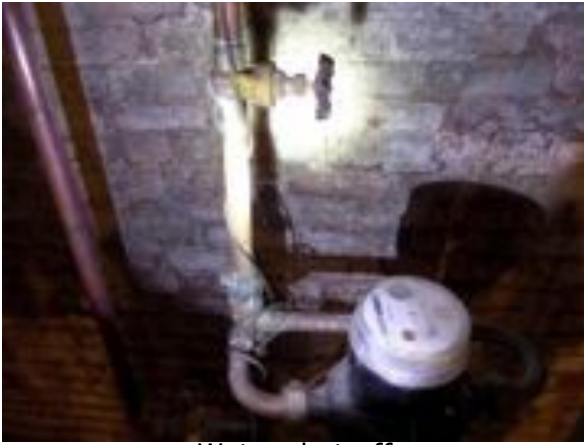
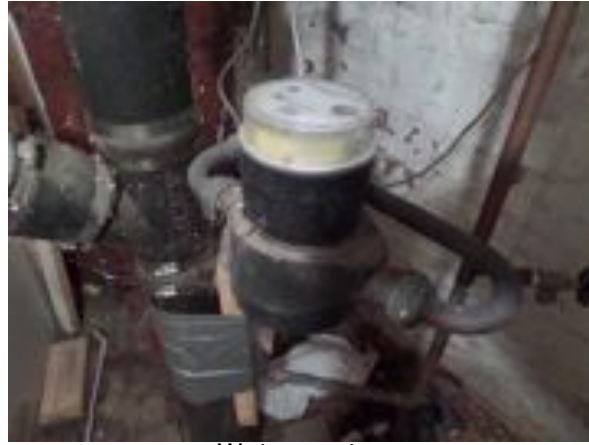
05/31/2014 No defects noted in plumbing system at time of inspection.

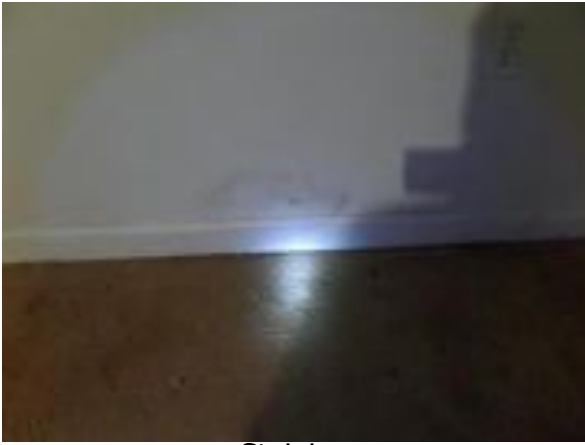
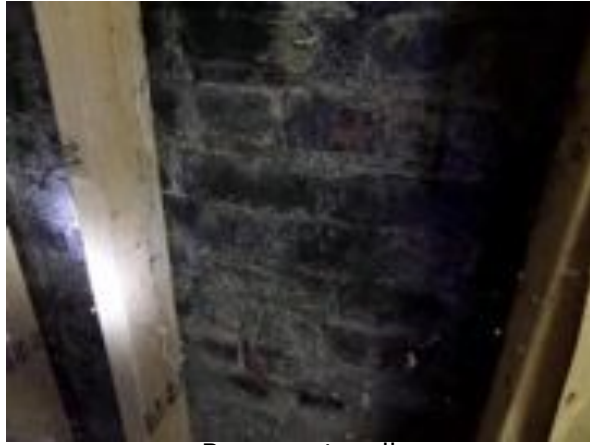
Mold-like substance observed on outside wall in 142 side basement. Musty smell and moist conditions were noted. Brick wall felt wet to the touch. A black substance was observed on exposed section of brick wall. Extent of growth could not be determine due to obstructing objects and finished surfaces. Staining noted on finished drywall. Mold can pose a serious health hazard to occupants. Recommend hiring a qualified mold testing/remediation company in order to verify existence of mold and extent of mold growth. Mold remediation is likely to cost in excess of \$1500.

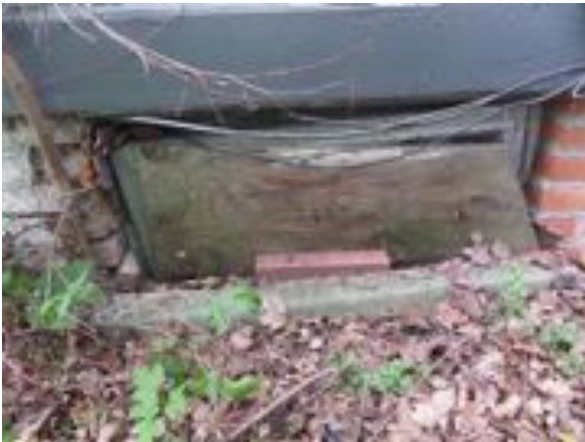
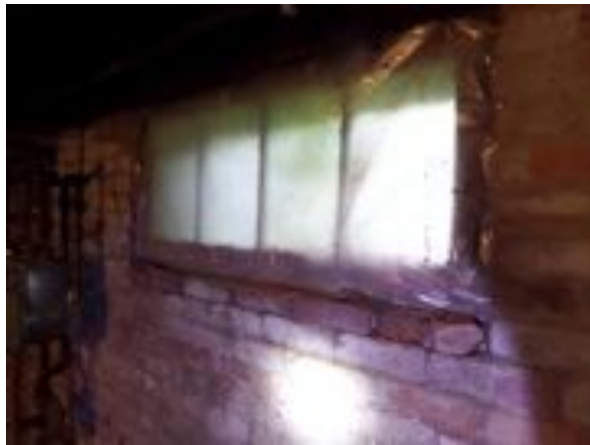
Basement windows appear to be sealed at time of inspection. Basement windows are critical in reducing moisture in basement via ventilation. Recommend hiring a qualified contractor to provide needed ventilation in basement.

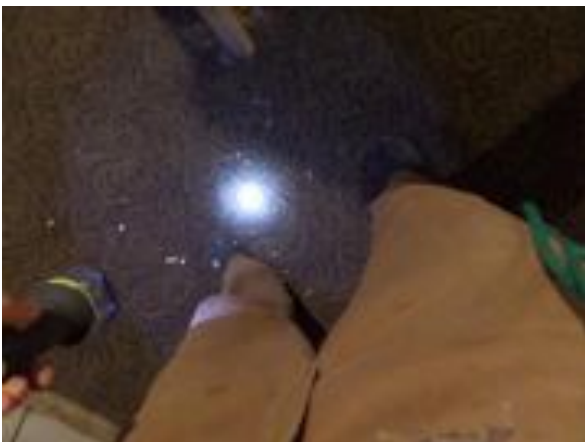
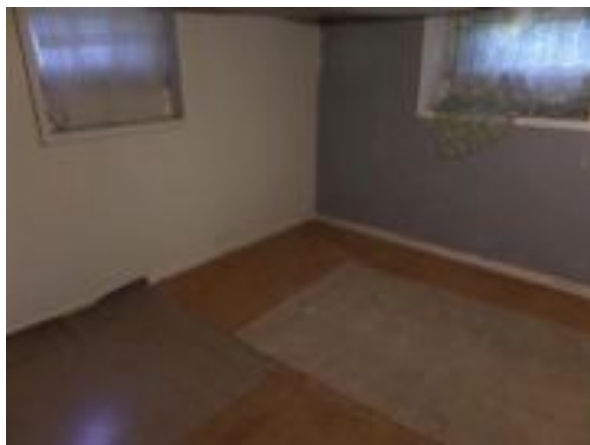
Carpet installed in 142 side of basement seems uneven due to irregular surface beneath. This may cause unsure footing. Recommend hiring a qualified contractor to repair as necessary.

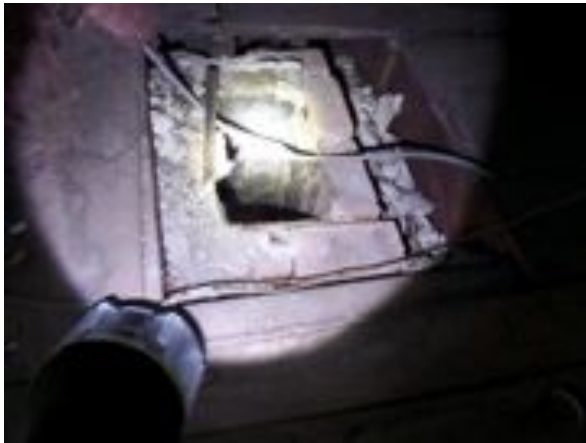
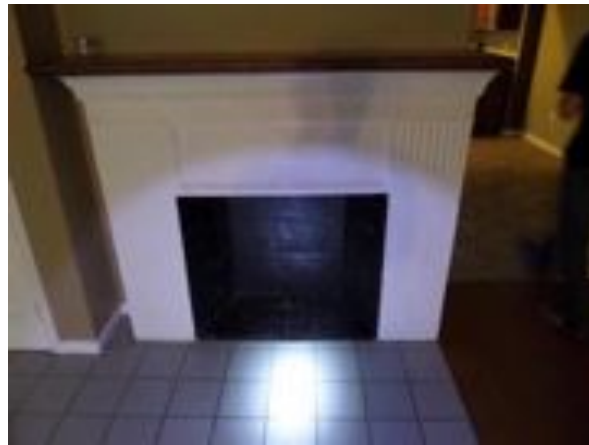
Fireplace has been decommissioned. Chimney has been taken down below roof and is not in operable condition. Fireplace is decorative only.

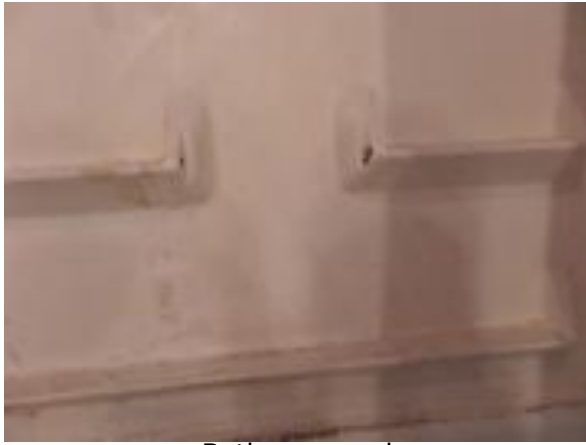
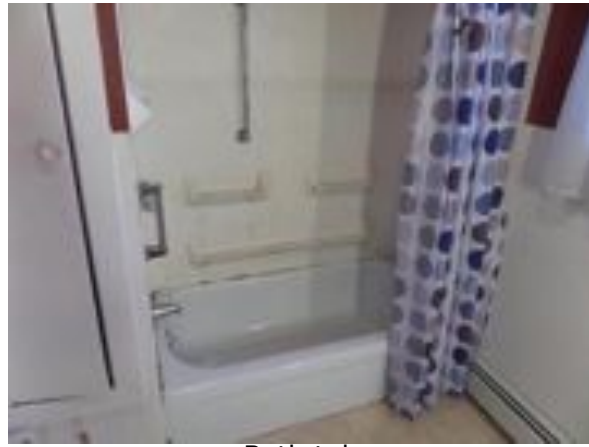
Bathroom surround towel rod is missing leaving holes exposed. Moisture may be able to get behind surround and cause damage. Recommend hiring a qualified contractor to repair as necessary.

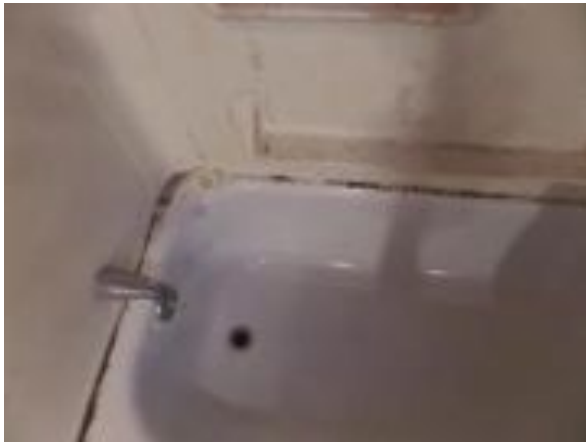
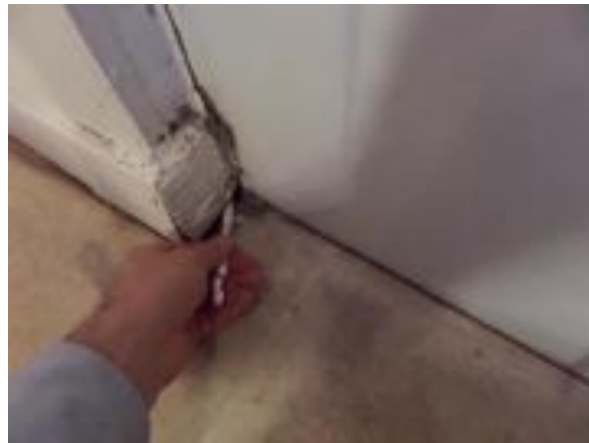
Noted missing caulk in bathtub area. This will allow water penetration to effect sub flooring and may damage wood. Recommend a qualified contractor repair as necessary.

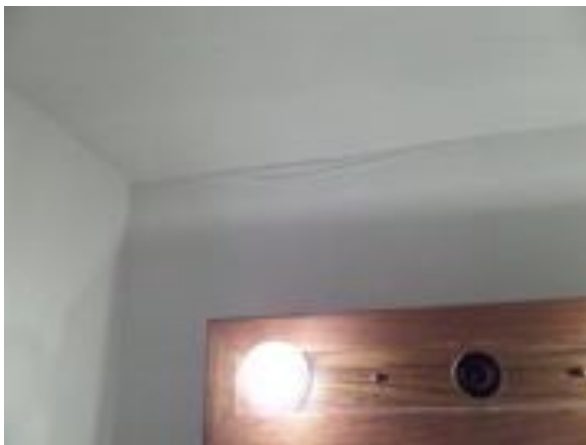
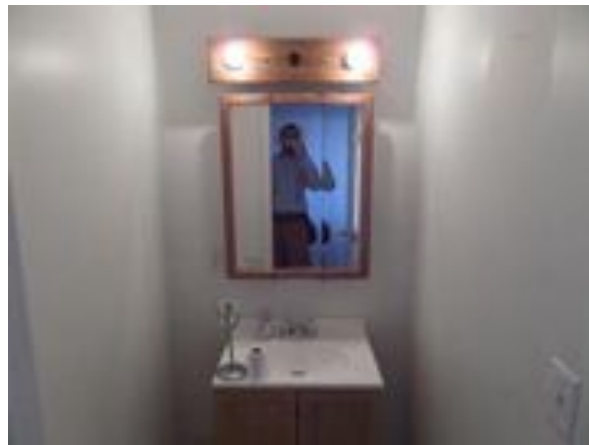
Open light socket noted in light fixture in half bath at time of inspection. Without a bulb screwed in, an open light socket may allow electric shock or fire. Recommend installing light bulb in open socket.

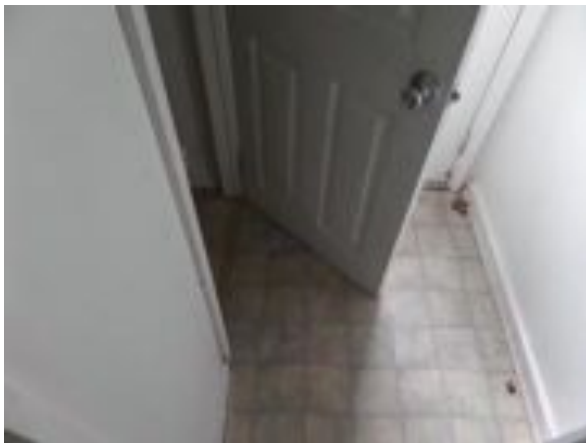
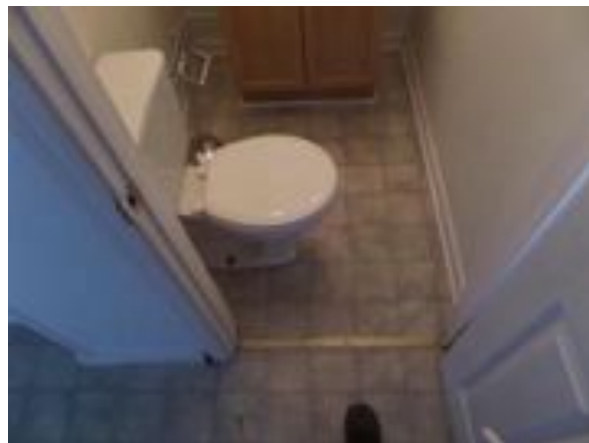
Floor just outside bathroom feels spongy underfoot. This may be due to deterioration of the subfloor. Recommend hiring a qualified contractor to repair as necessary.

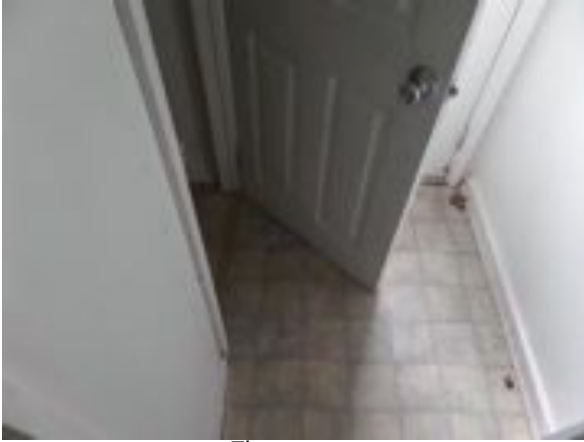
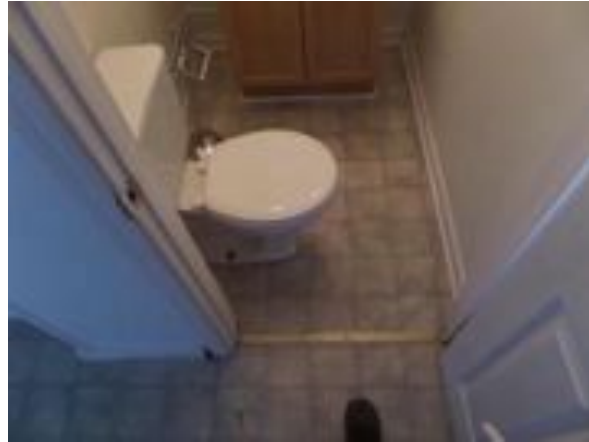
05/30/2014 Bathroom door sticks on floor when opened. This may be due to poor installation or movement in the structure after the door was installed. Recommend hiring a qualified contractor to repair as necessary.

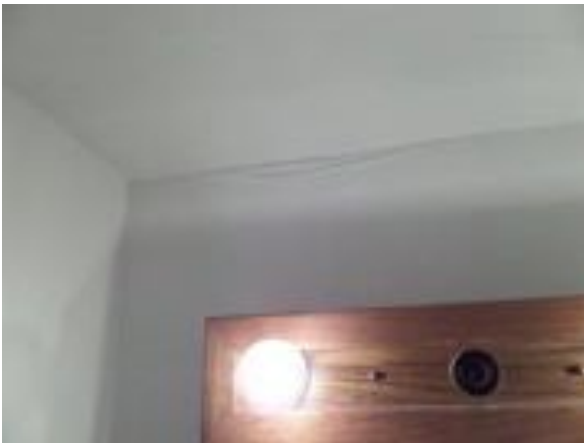
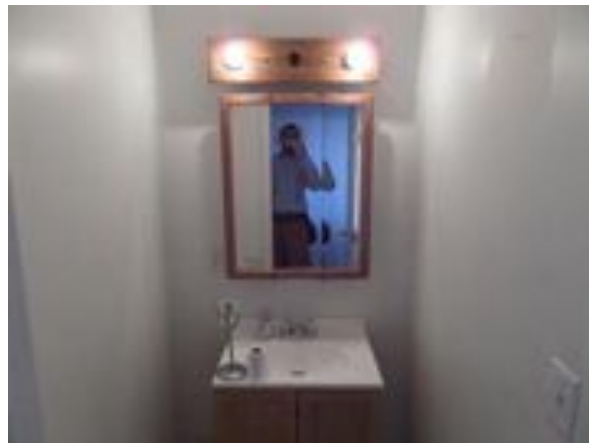
05/30/2014 Area of concern on bathroom wall where it meets the ceiling. Paint has drooped indicating moisture behind it. (See roof section).

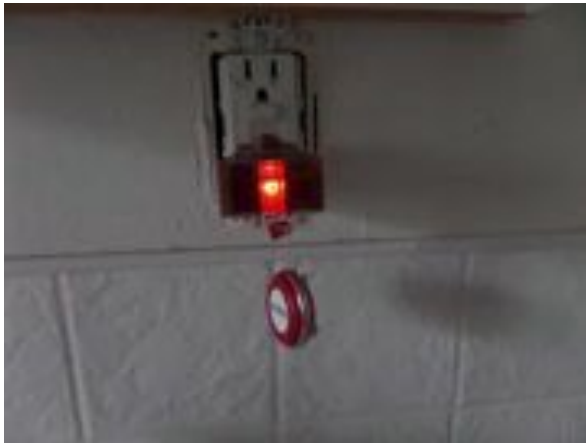
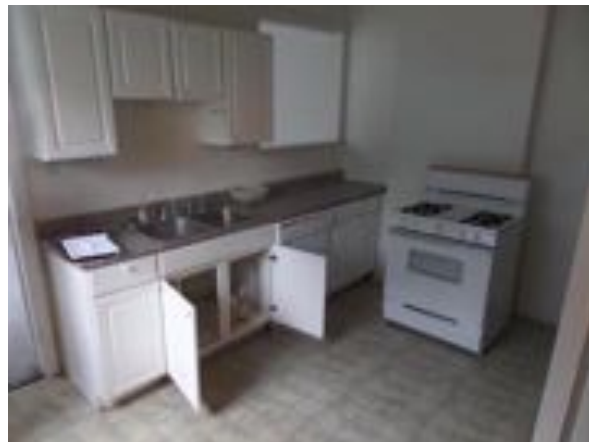
05/30/2014 GFCI outlet test results indicate an open ground. This condition may pose a greater risk for electric shock or fire and therefore a safety concern. Recommend hiring a qualified electrical contractor to repair as necessary.

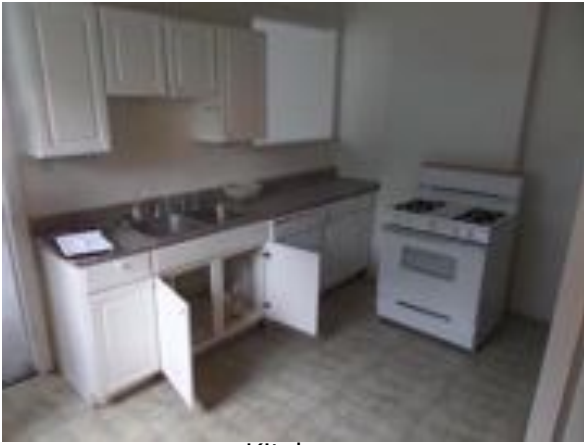
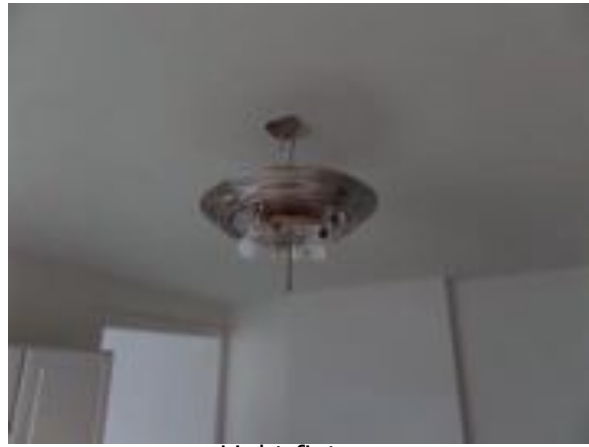
05/30/2014 Kitchen ceiling light fixture noted hanging by electric wires. Fixture may fall, malfunction, or cause harm to occupants. Recommend hiring a qualified contractor to repair as necessary.
