██████████
██████████ Pawling Ave
Troy, 12180
HIN™: 121806288
Email: ██████████
Inspection Date: 05-28-2014

Hollis Home Inspection
J Hollis Allison
199 Green st Hudson, New York 12534
Phone: (518) 421-6069
E-Mail: hollishomeinspection@gmail.com

Welcome and thank you for choosing Hollis Home Inspection.
 This report is designed to be as thorough as possible, but also clear and concise.
 If you have any questions please call us at (518) 421-6069

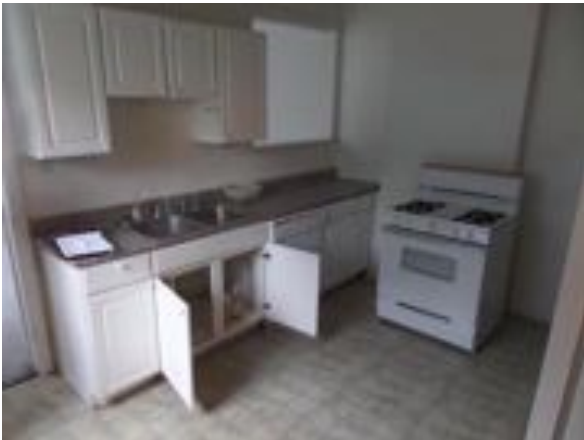
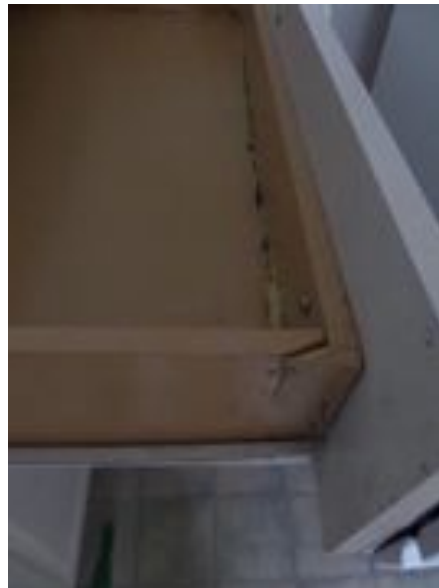
Cabinetry in need of attention. Upper door is loose and drawer does not open easily. Recommend hiring a qualified contractor to repair as necessary.

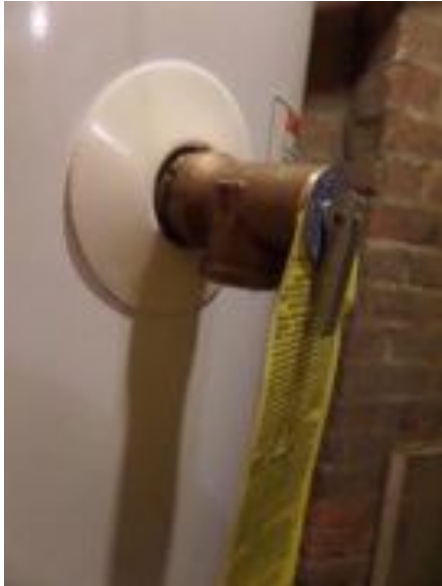
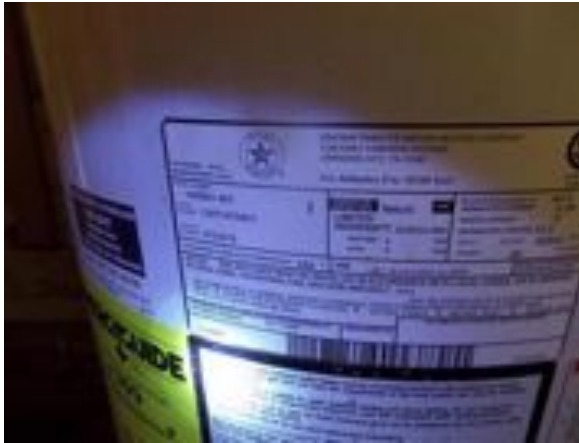
Safety extension for TPR valve was not installed. A safety extension is designed to carry hot water safely to the ground in the event of an over pressurization. Without a safety extension occupants may be at risk of burning or other injury during an over pressurization. Recommend hiring a qualified plumbing contractor to repair as necessary.

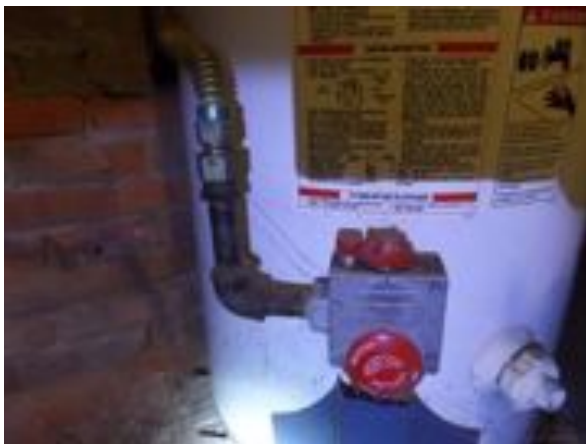
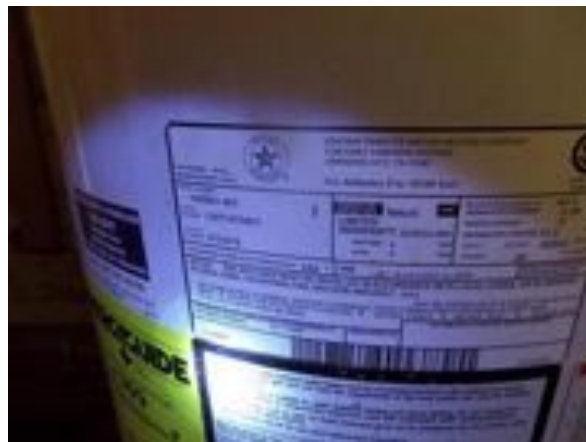
No drip leg was noted installed on the gas supply line to the water heater. A drip leg is a device used to trap impurities in the gas line. A gas line without a drip leg may cause improper function of the gas appliance which may be hazardous. Recommend a qualified plumbing contractor repair as necessary.

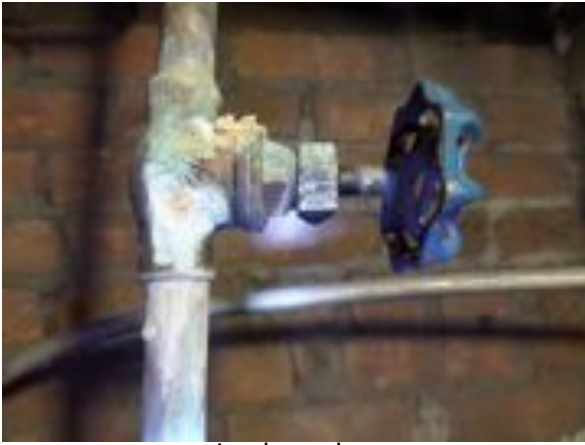
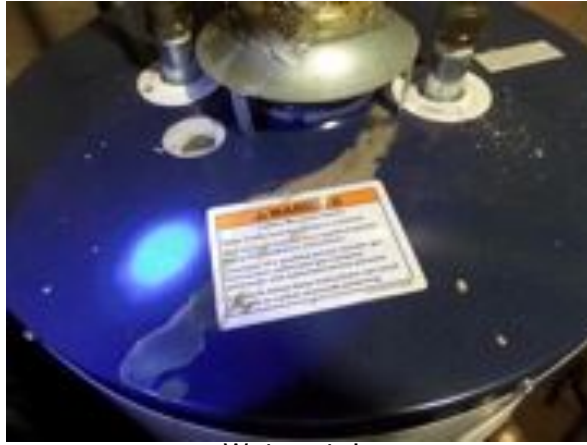
An active leak was noted at time of inspection near the water heater. The supply valve above the water heater was noted with an active drip. Water dripping on top of water heater may lead to rust or corrosion. Recommend hiring a qualified plumber to repair as necessary.

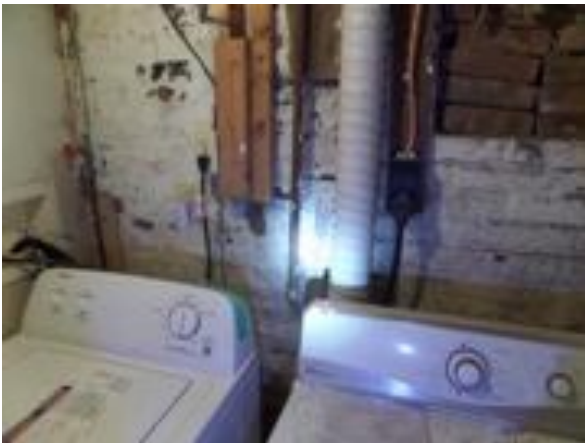
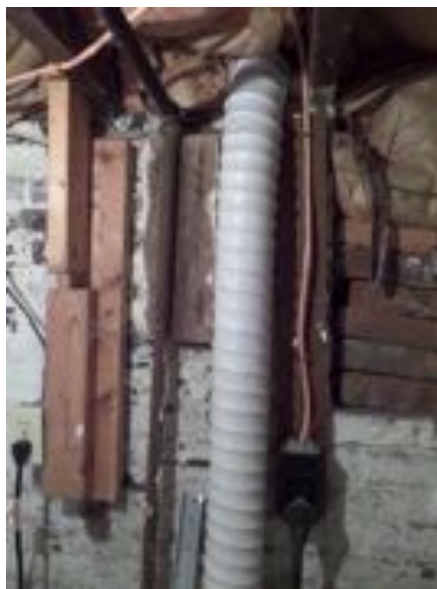
Dryer exhaust duct made out of ribbed vinyl. Ribbed duct is more likely to collect lint which may clog duct and reduce dryer efficacy. Vinyl material is inferior because it may catch fire in the event of a clog. Recommend replacing ribbed vinyl duct with rigid metal duct.

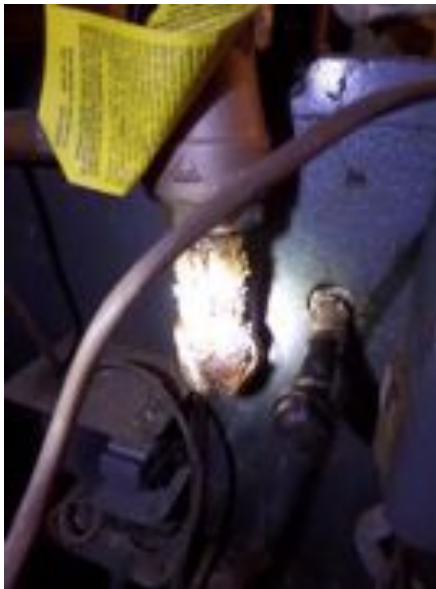
142 side Boiler noted in poor condition. Rust and/or corrosion was observed in several areas including the circulator pump and surrounding plumbing. An active leak was noted in plumbing exiting boiler. A ticking noise was observed as well. Additionally, heat was not received on the third floor. Recommend hiring a qualified HVAC contractor to assess the condition of the boiler and estimate the needed repairs which may cost \$1500 or more.

Active leak area

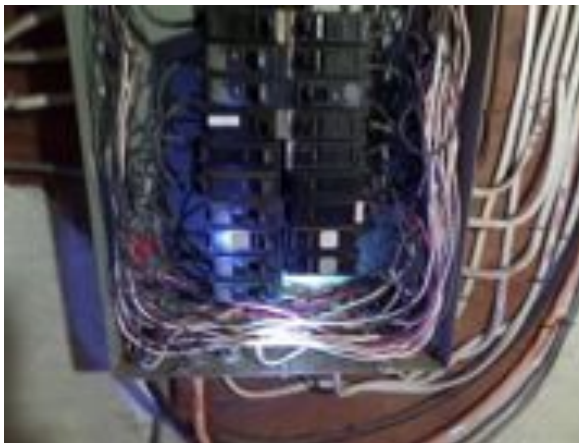
Electric Panel

One double tapped breaker was found at time of inspection. Double tapped breakers are a safety concern as they pose a risk of micro-arcing which may lead to fire. Recommend hiring a qualified electrical contractor to repair as necessary.
